# Property Inspection Report

**300 Chestnut Way, Apt. 1B  
Sacramento, CA 95814**

**October 26, 2026**

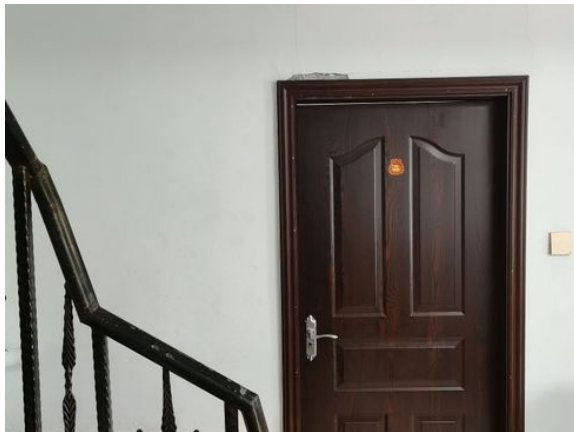
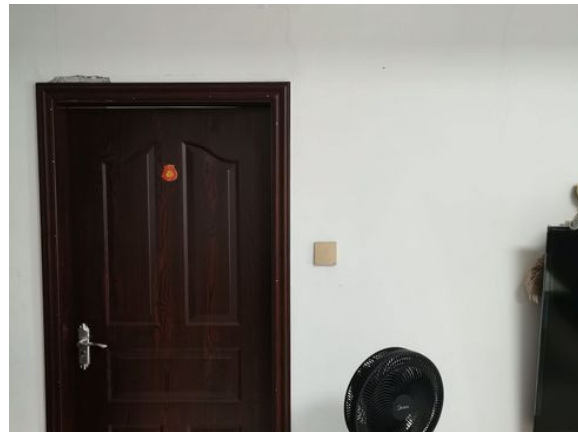
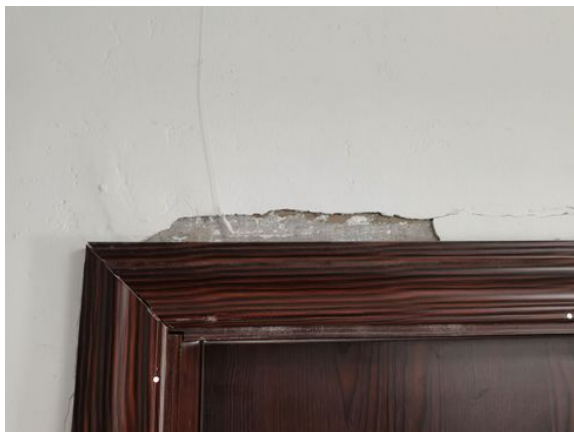
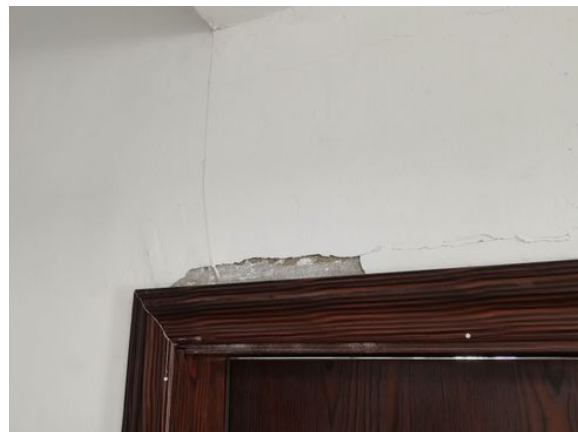
Entry door frame head and adjacent wall

The top of the south entry door frame shows a visible gap between the frame head and the wall surface above it, accompanied by peeling and flaking paint in the immediate vicinity that exposes the underlying substrate. A hairline crack extends from above the frame into the wall surface. The paint failure is concentrated at the top of the frame where the gap is widest, with loose flakes visible across a section of several centimetres. Taken together, the gap, exposed substrate, and cracking are consistent with settlement movement at the door frame or differential movement between the frame and the surrounding wall structure.

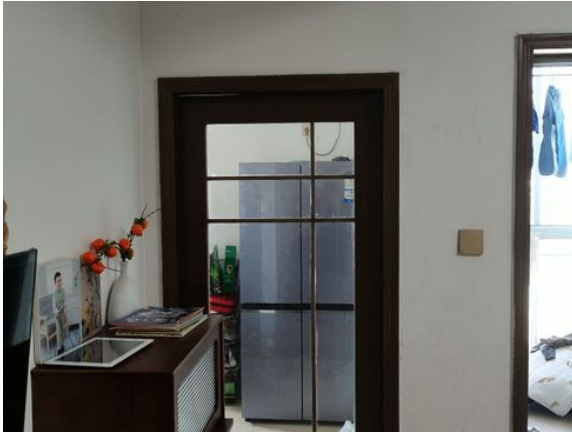
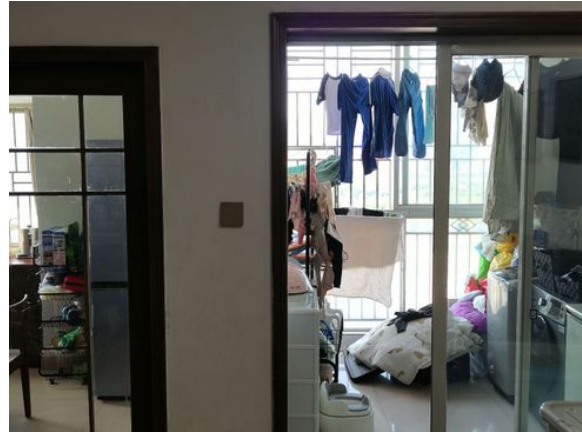
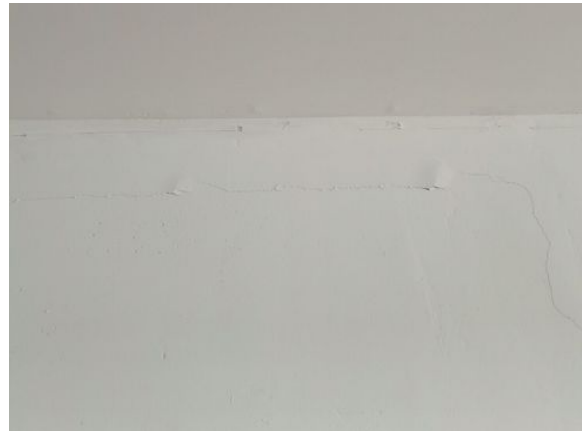
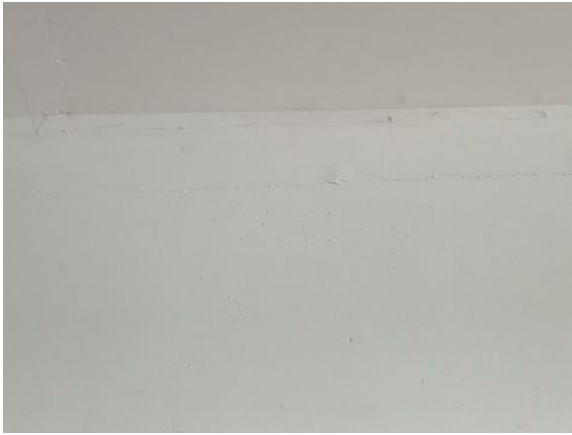
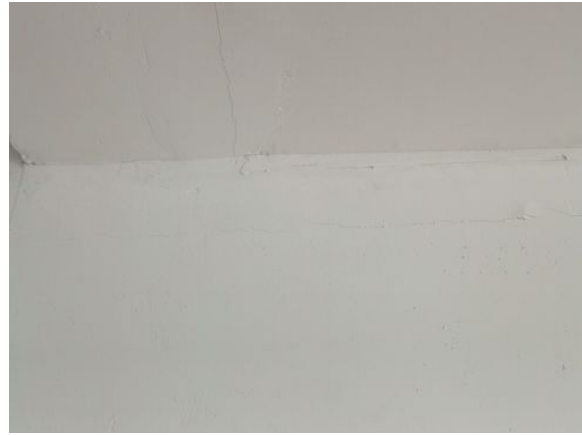
**West wall below the light switch**

The west wall below the light switch presents several overlapping crack conditions across a localised area. A pronounced diagonal hairline crack runs toward the corner where the wall meets the door frame, and additional horizontal cracking is present at the wall-ceiling junction with visible paint separation. At the base of the wall near the door frame, a gap with exposed substrate is visible where the wall surface has pulled away from the framing. The concentration and variety of crack orientations in this area — diagonal, horizontal, and at the base — are consistent with ongoing or prior movement at this wall section.

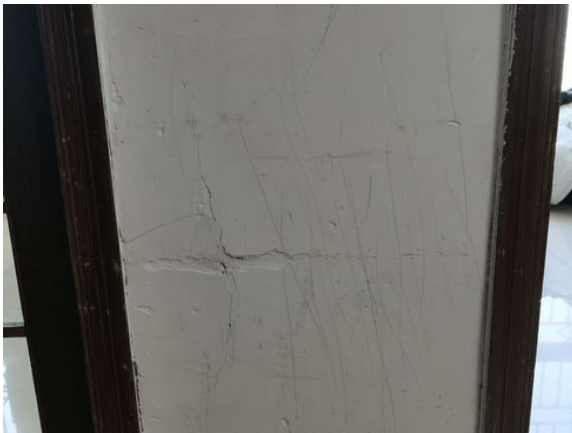
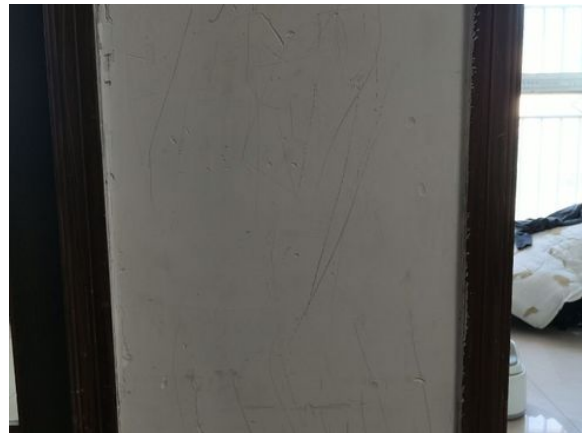
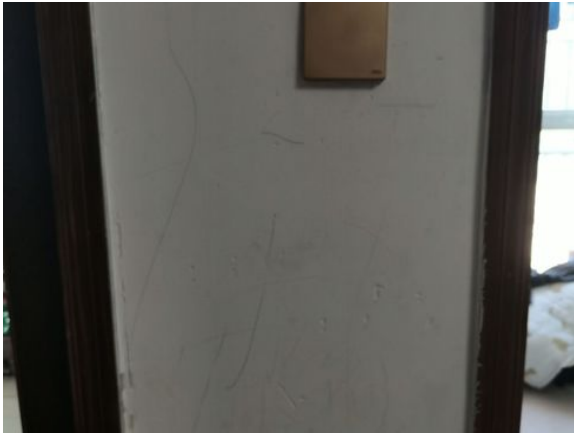
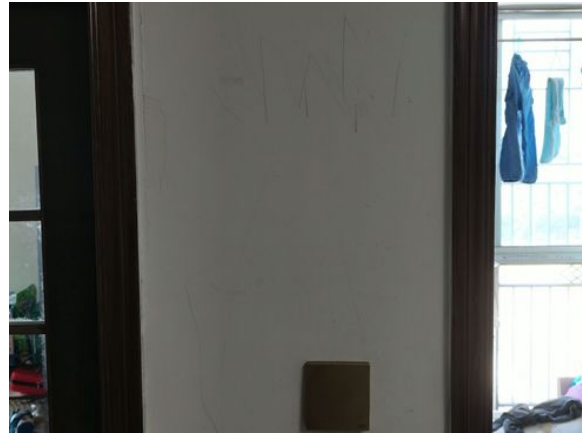
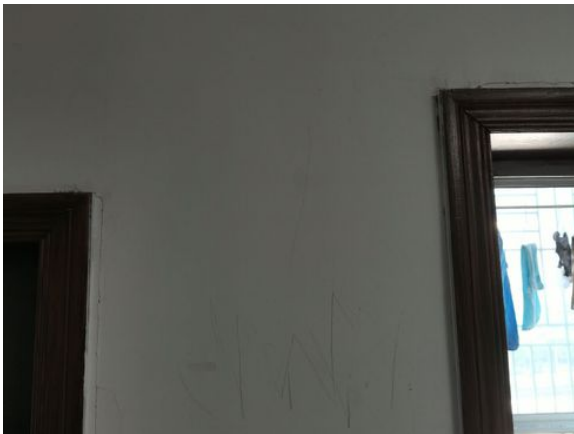
#### **Wall panel between the dining area and laundry room doors**

The wall panel situated between the two door openings on this wall shows extensive surface distress across its full face. Linear scratches and gouges run across the panel in multiple directions, and a horizontal crack consistent with drywall joint movement is present at mid-panel height. Evidence of prior patching is visible but the repair is uneven, with the treated area remaining visible against the surrounding paint finish. The extent of the scratching and the prior repair attempt together indicate this panel has experienced significant contact and has been addressed at some point without full restoration.

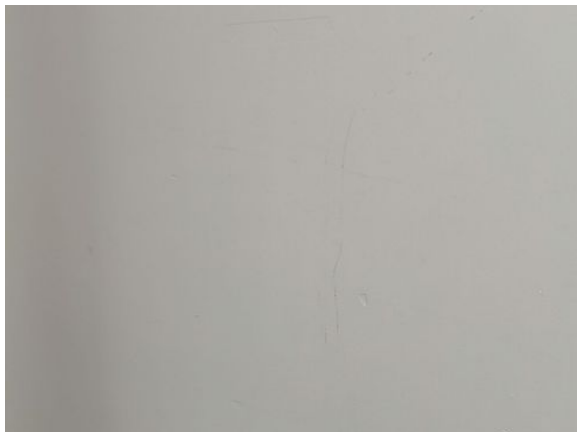
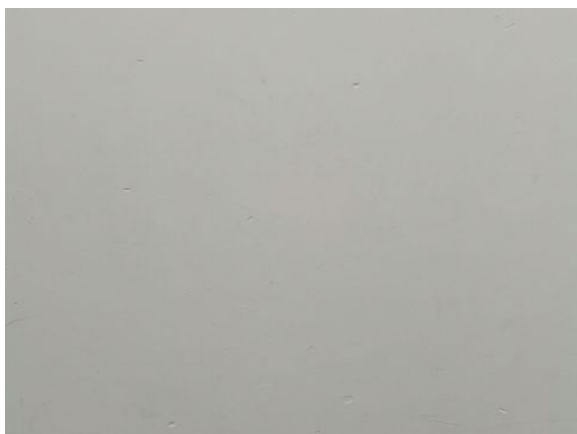
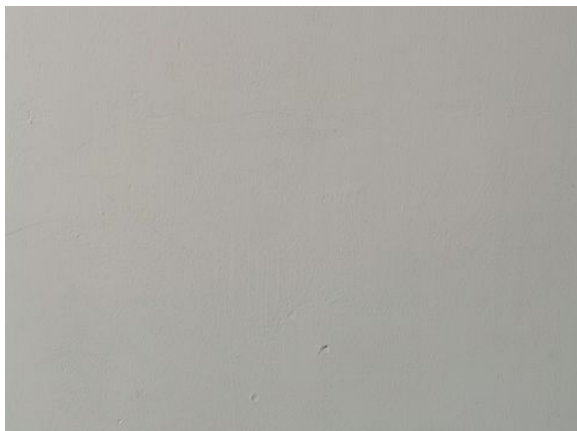
**North wall above the sofa**

The north wall surface directly above the sofa position shows a concentration of surface distress including multiple scratches, gouges, and surface abrasions where the paint layer has broken. In one location, a section of wall material appears raised or torn, with lifted material at the edge. Deliberate red marker or crayon markings in letter-like shapes are visible on the same wall surface, accompanied by scuffs and irregular lighter-toned areas that appear consistent with prior touch-up attempts that did not fully conceal the underlying markings. The combined area of distress spans a section of the wall directly accessible from the sofa position.

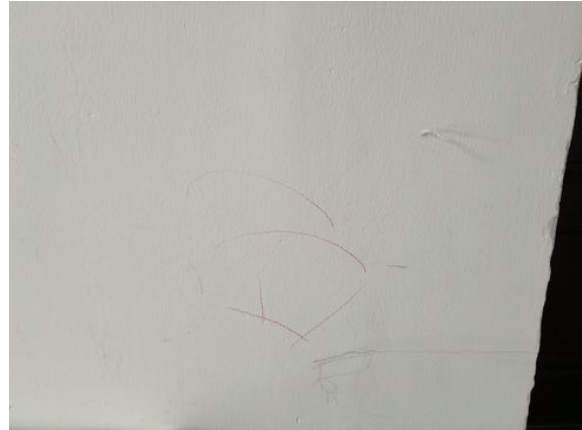
**Wall beside the apartment entrance**

The wall surface adjacent to the apartment entrance shows a combination of conditions: red and black pen or marker writing, crayon markings, adhesive sticker residue, and nail holes are all present across the surface. The area around the light switch also shows imperfect patching, visible as a slightly raised or discoloured section of the wall face. The adhesive residue and nail holes indicate prior fastening of items to this surface, and the markings span a broad section of the entry wall at a height consistent with access from standing height and below.

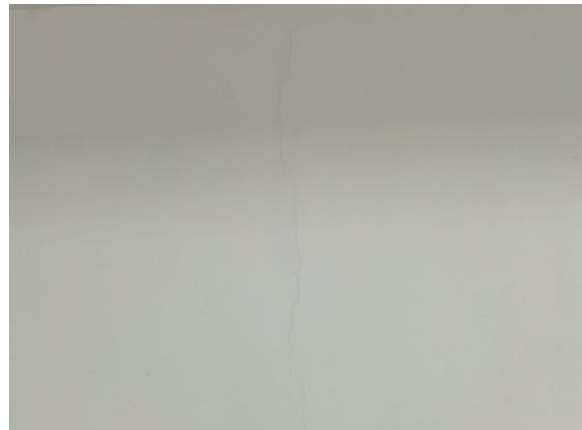
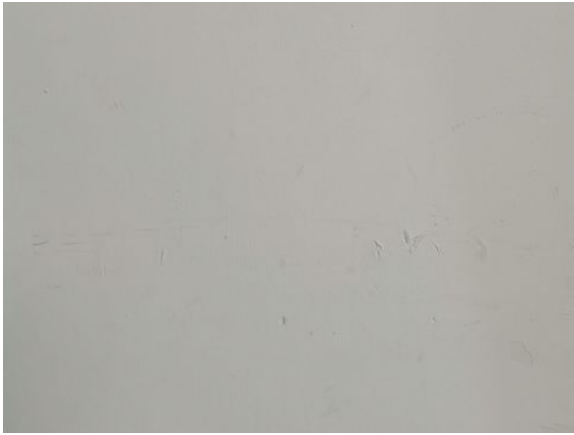
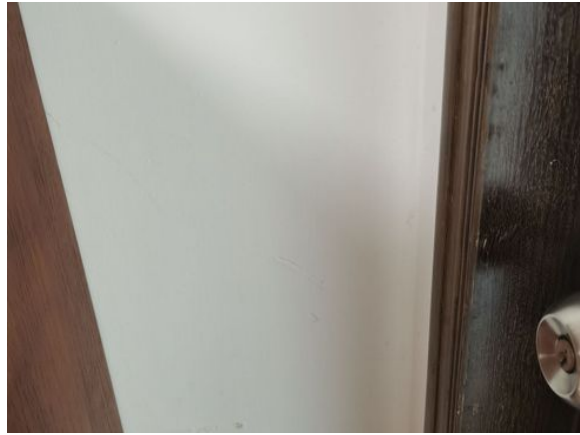
**East wall beside the TV**

The east wall beside the TV position shows a vertical crack running from the ceiling junction downward, with lifted and flaking paint material along its length. In addition to the crack, multiple scuffs and surface gouges are present on the same wall section. The crack originates at the ceiling-wall junction and follows a largely vertical path, with the paint failure concentrated along the crack line itself. The surrounding surface shows general scuffing consistent with contact at furniture height.

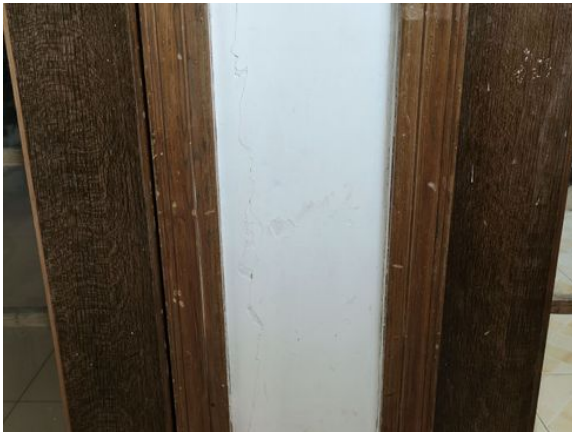
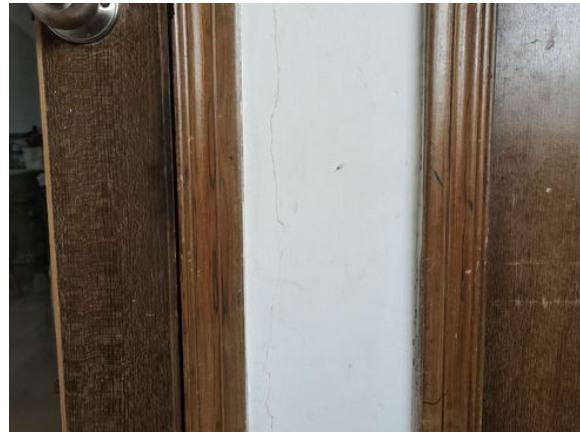
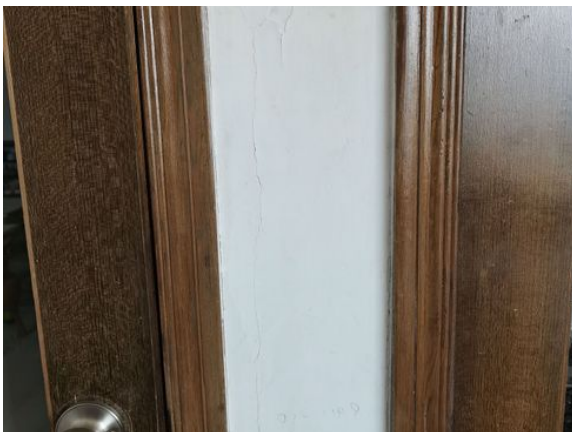
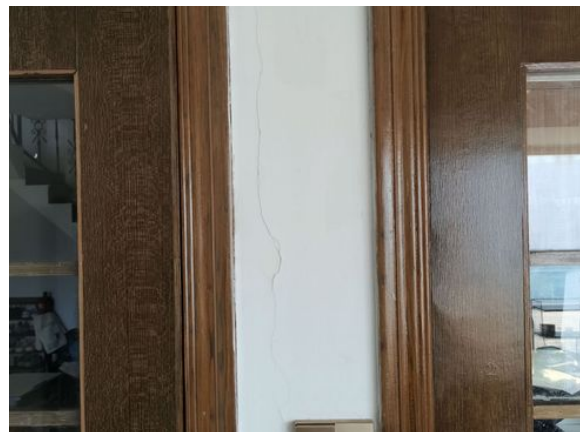
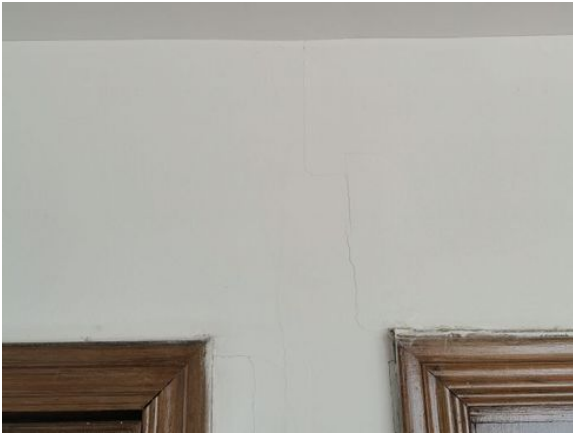
#### **Wall section between the two door frames**

The wall panel between the two door openings shows a continuous vertical hairline crack running the full height of the wall, with branching lateral offshoots visible above the frame levels. Paint is peeling in this area, and the base of the wall shows missing material where the surface has deteriorated at floor level. At the upper corners of one door frame, the trim does not sit flush, leaving visible gaps between the frame and the wall. The combination of a full-height crack, branching lateral cracks, peeling paint, material loss at the base, and trim separation suggests this wall section has experienced structural movement of some duration.

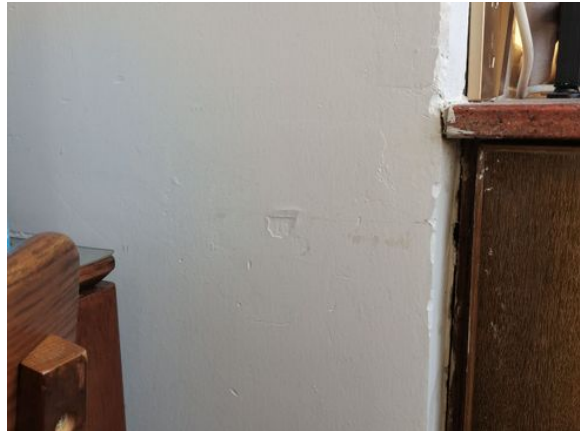
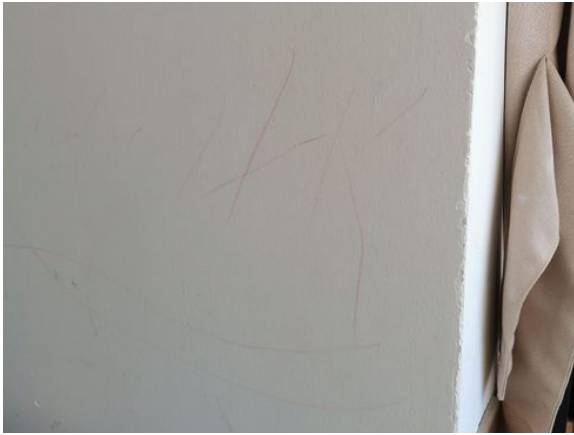
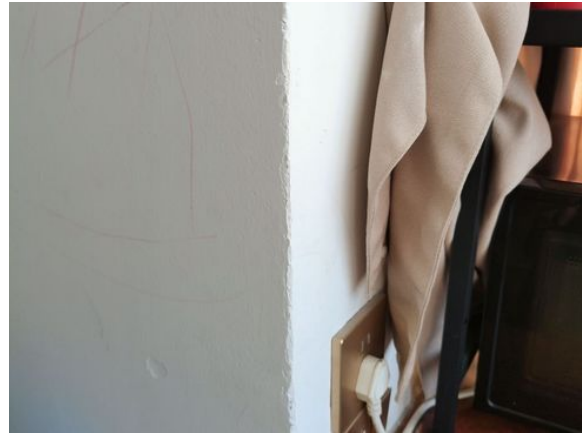
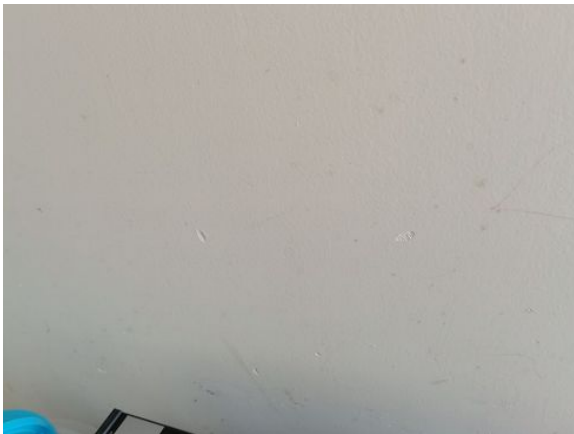
#### **South wall — markings, puncture voids, and impact gouges**

The south wall documents several overlapping conditions. Puncture voids are present where material has been driven into the wall surface, and impact gouges with missing surface material are visible at multiple locations. The wall corner edges show deterioration at the arris, with the corner bead material compromised. Across a broad area of the same wall surface, red and pink crayon or marker drawings are present, covering a substantial proportion of the visible wall face. The deliberate markings and the impact damage appear independent of one another and together represent a range of conditions requiring remediation.

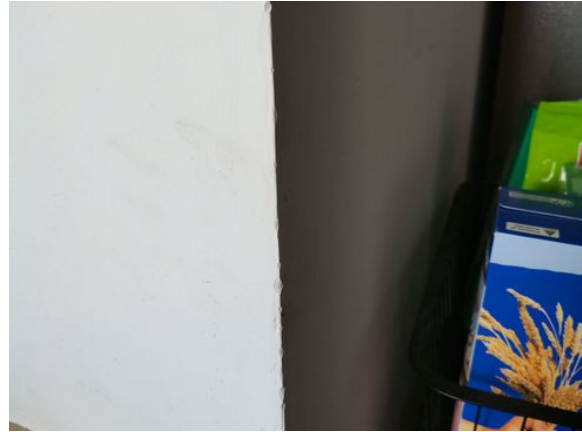
**Wall corner near the kettle area**

The vertical corner bead along the wall corner nearest the kettle position shows chipping, crumbling, and missing surface material along its full vertical length. White debris consistent with disintegrated corner bead material is visible on the countertop surface below. The deterioration appears active rather than historic, in that loose material is present rather than a previously stable exposed edge. This corner will require replacement of the corner bead and associated patching before the surface can be repainted.

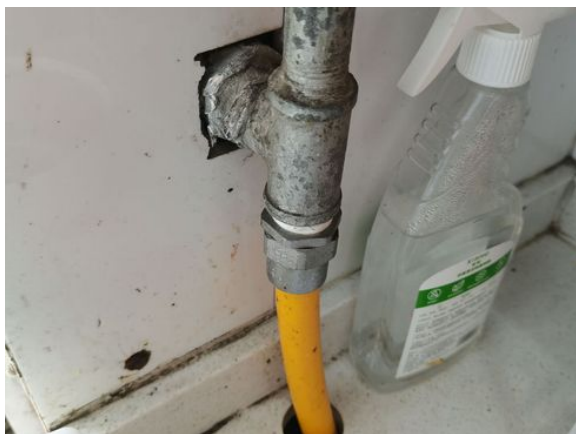
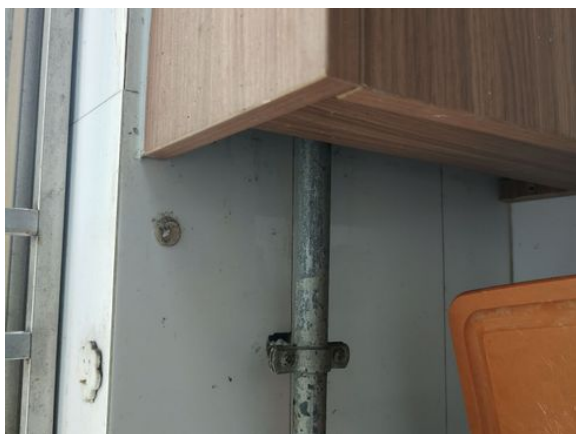
**Exposed gas pipe and wall penetration**

An exposed gas pipe in the kitchen shows extensive surface corrosion along its visible length. The wall penetration through which the pipe passes is unsealed and shows deteriorated finishing material around the opening, leaving the gap between the pipe and wall surface open. A yellow flexible gas connector passes through a hole in the countertop that has no collar or protective sleeve, and the countertop opening itself is unfinished. Additionally, an electrical outlet cover plate in the same area is missing or damaged. Taken together, the corroded gas pipe, the unsealed wall penetration, the uncolored countertop gas connector pass-through, and the compromised outlet cover constitute multiple conditions warranting immediate attention from qualified tradespeople. No cause is assigned here, but these conditions should be reviewed by a licensed plumber and electrician before the unit is occupied.

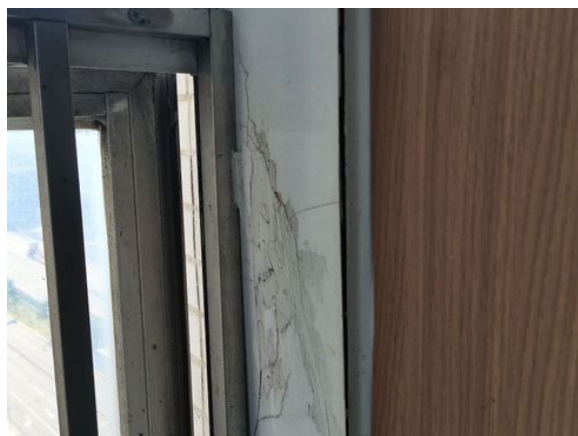
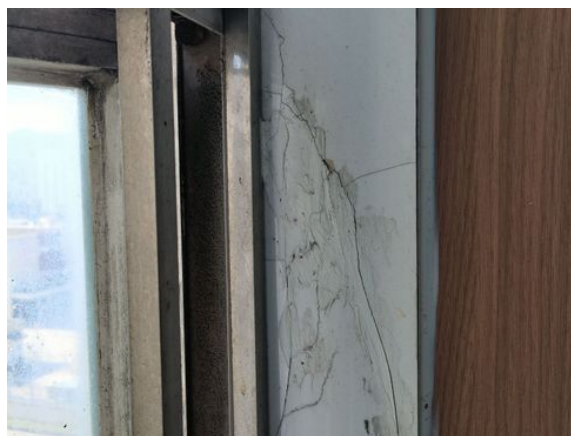
#### **Shattered wall tile adjacent to the window**

The wall tile on the wall adjacent to the window has undergone extensive shattering, with tile material missing across a large area and the underlying substrate exposed over the void. The damage is not confined to a single tile — multiple tile positions are affected, and the substrate behind is visible and unprotected. Broken tile fragments and disturbed grout are present at the perimeter of the missing area. This condition exposes the wall substrate to moisture and contact and represents a failed wall surface component.

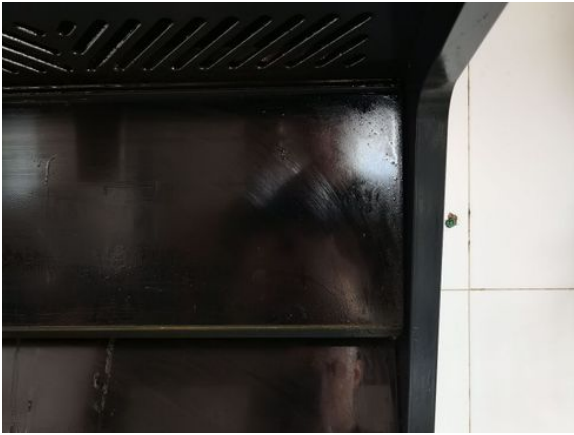
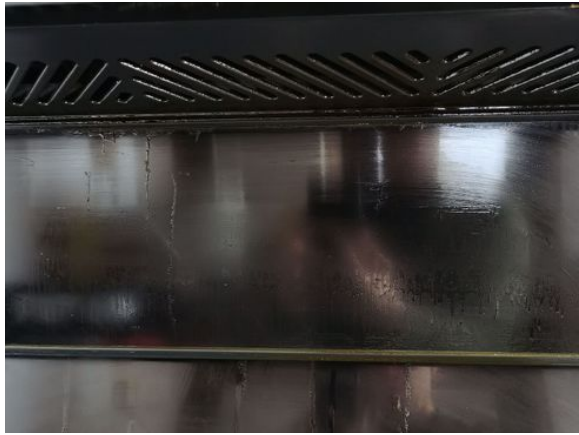
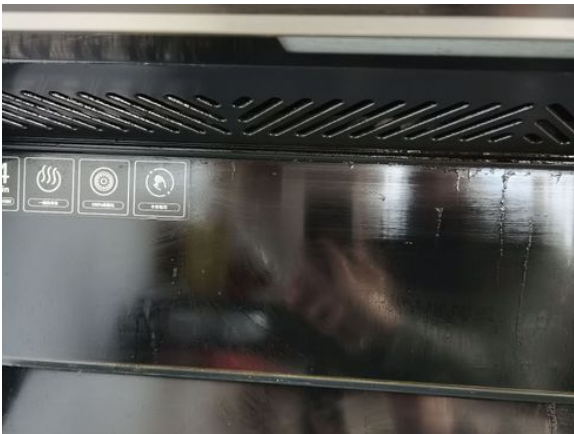
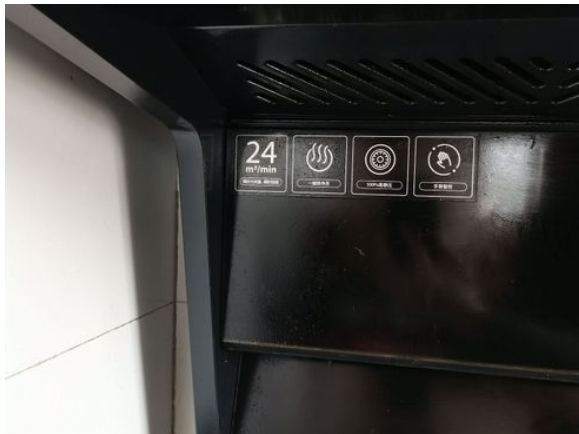
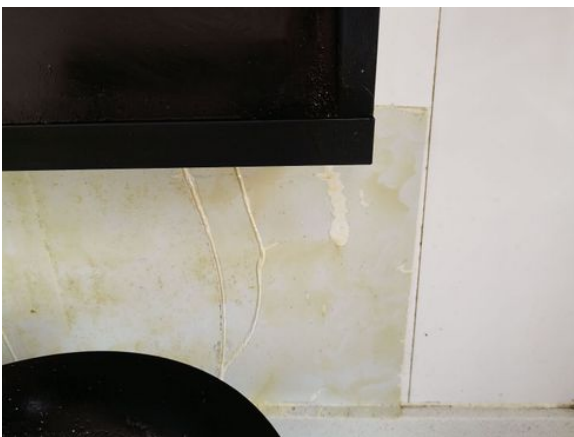
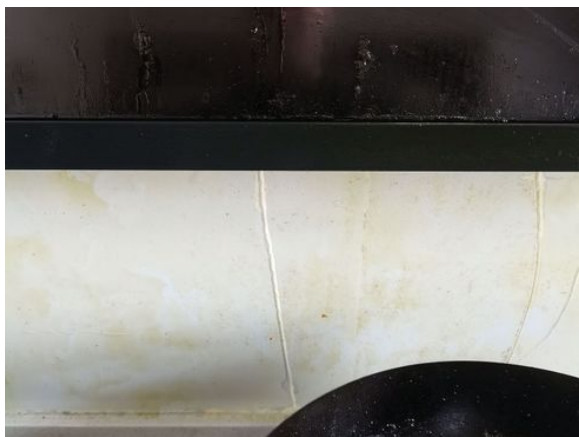
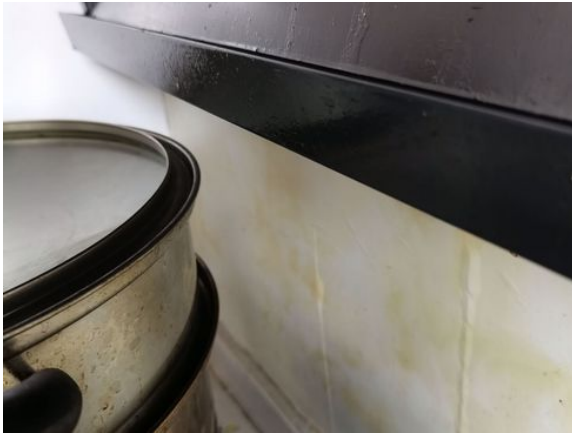
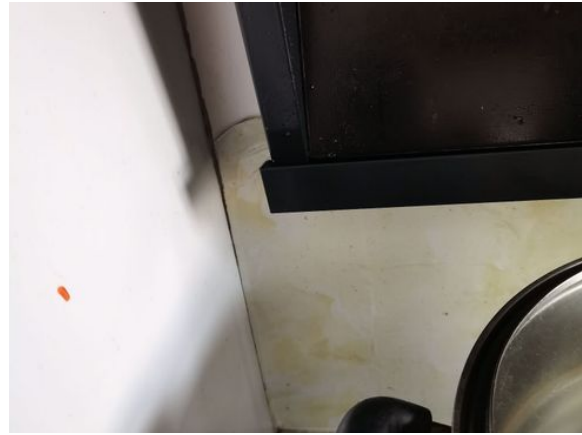
### Range hood and backsplash buildup

The interior baffles and grille of the range hood are coated with a heavy layer of grease residue across their full width. The buildup is thick and distributed uniformly, indicating extended use without cleaning of the hood's filtration components. The tile backsplash behind the stove extends approximately 60 centimetres and shows widespread yellowed and greenish-brown grease staining across most of its surface. The staining is heaviest immediately above the cooking surface and diminishes toward the top of the tiled area. These conditions are consistent with extended cooking use without regular cleaning of the affected surfaces.

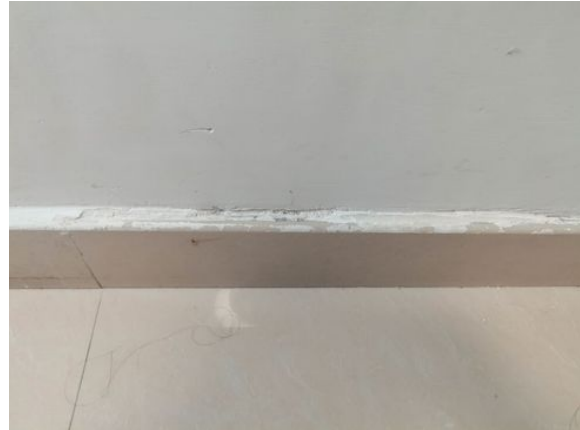
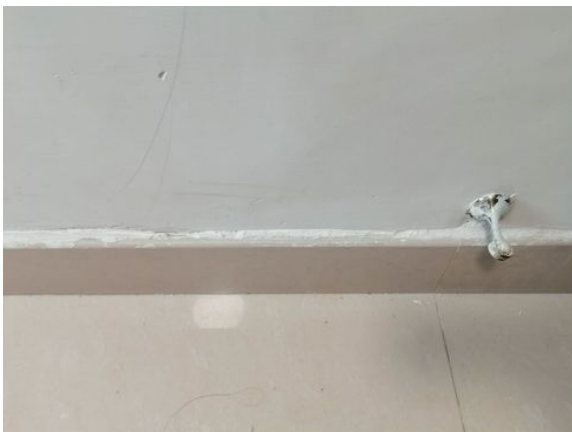
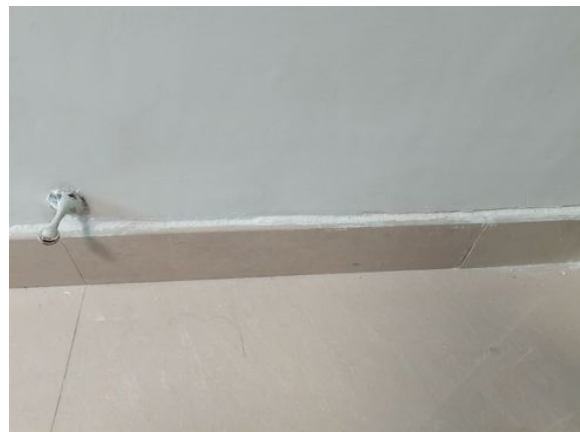
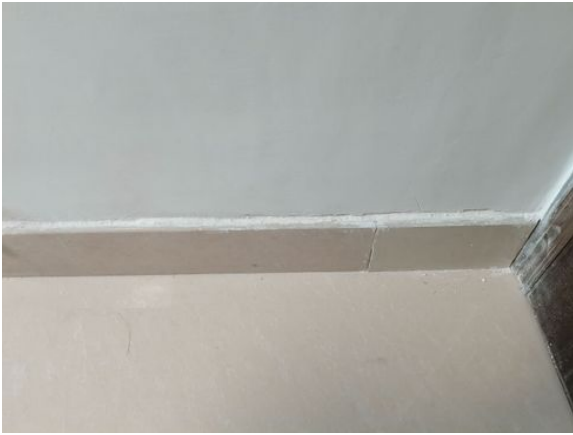
**Baseboard condition**

The baseboard along at least one wall of this room shows an unfinished or unpainted face, with peeling and flaking paint along the top edge that exposes the substrate beneath. Protruding fastener hardware is visible at multiple points along the board. These conditions are consistent with a baseboard installation that is either incomplete or has deteriorated to the point that the paint and finish have failed. The exposed substrate and protruding fasteners indicate the baseboard requires remediation beyond ordinary cleaning or touch-up.

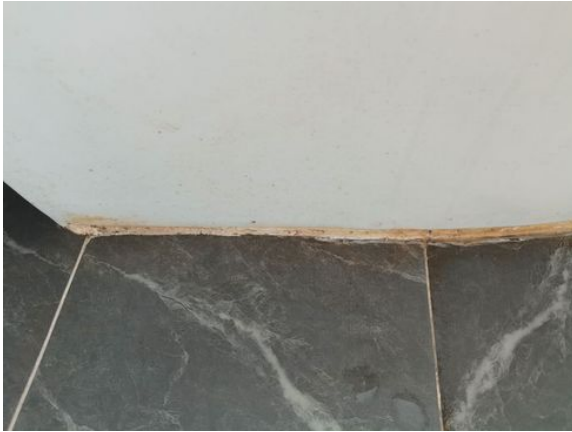
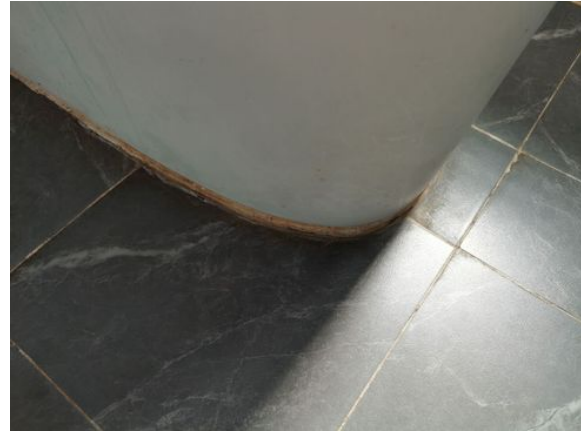
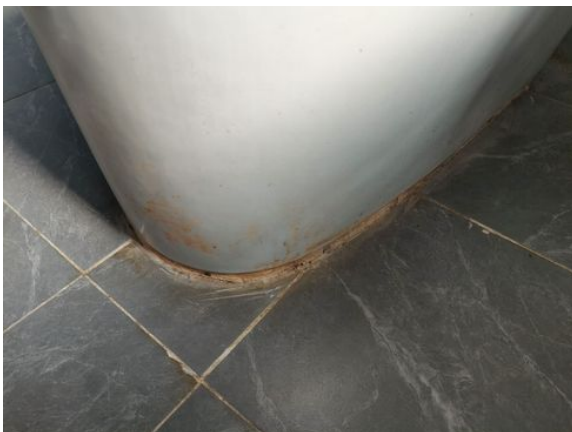
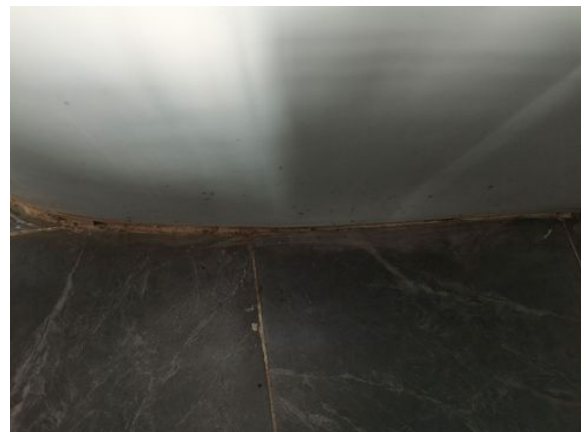
### Toilet base-to-floor junction

The caulk and sealant at the base of the toilet where it meets the floor tile has failed and is missing across all visible angles of the junction. The substrate beneath the toilet base is exposed and shows dark staining and debris accumulation in the gap. A failed seal at a wet fixture of this type allows moisture to penetrate beneath the toilet base with each use, and the staining present at the exposed substrate is consistent with ongoing or prior moisture ingress. This condition warrants prompt re-sealing after assessment of the substrate condition beneath.

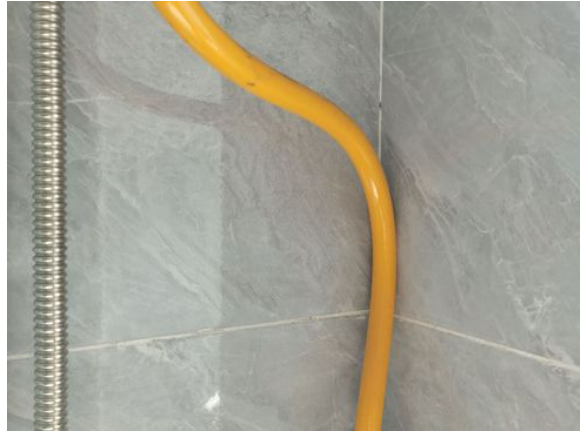
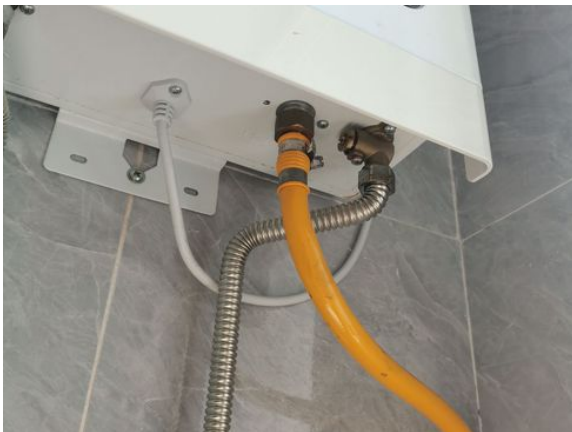
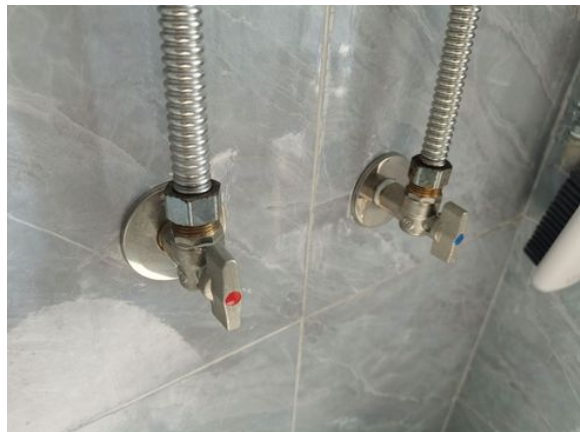
### **Gas supply line routing**

An exposed gas supply line is present in the bathroom without adequate wall finishing at its penetration point, leaving an incomplete opening around the line where it enters through the wall. At floor level, an electrical cord and water supply lines are co-routed in direct contact with the gas line. Corrosion is visible at the valve fittings. The co-routing of an electrical cord and water lines in contact with a gas supply line, combined with the corroded fittings and unsealed wall penetration, represents multiple conditions that should be reviewed by a licensed plumber and electrician. No cause is assigned, but the combination of utilities in direct contact warrants professional assessment.

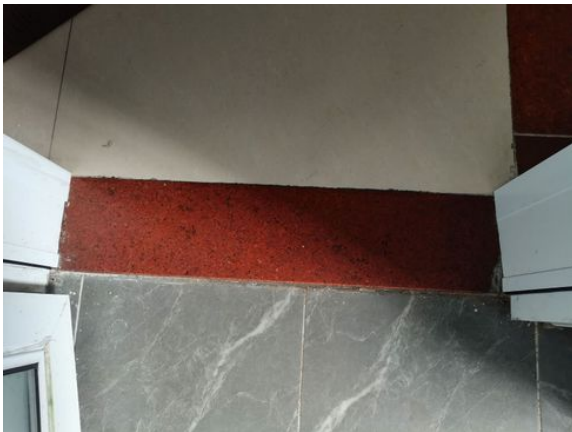
### Entry threshold — biological growth

The lower section of the door frame at the entry threshold shows biological growth consistent in appearance with algae or moss. The growth is present on the frame surface at a point that may be subject to moisture exposure. The sealant at the threshold-to-frame junction is absent or has failed, leaving the junction open. Biological growth of this character at an entry point is consistent with persistent moisture accumulation in this area.

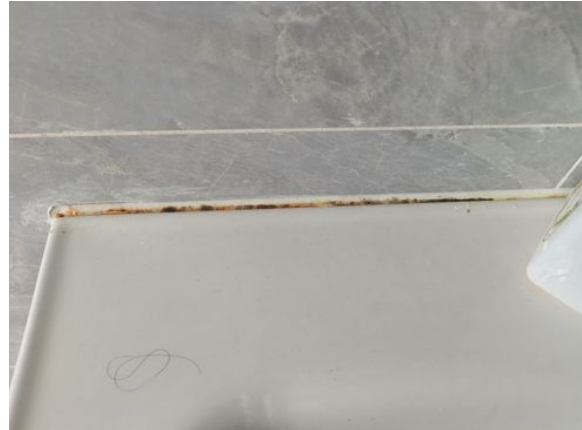
### Tile-to-vanity caulk seam

The caulk and grout seam where the wall tile meets the vanity surround shows dark brown-to-black spotting distributed across its length, with the sealant integrity visibly deteriorated. The spotting is consistent in appearance with mold or mildew accumulation at a wet area junction where the sealing has failed. A wide-angle survey photograph establishes the context of the vanity and tile layout, and a close-up photograph documents the condition of the seam itself. The failed sealant and biological spotting together indicate a condition requiring remediation at this junction.

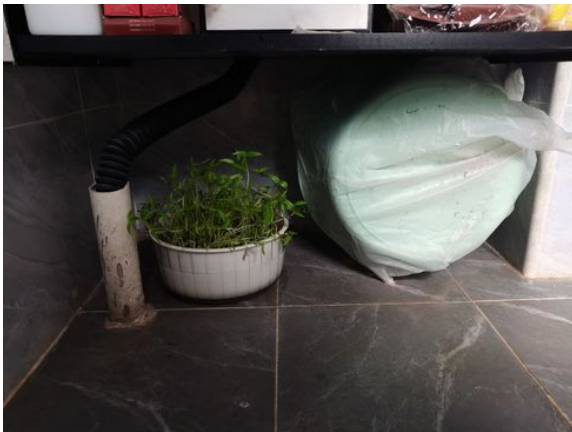
### Under-vanity drain pipe penetration

The drain pipe floor penetration under the vanity cabinet shows deteriorated caulk and a visible gap around the pipe where it exits through the floor, leaving the penetration unsealed or poorly sealed. An improperly routed corrugated drain hose is also present in the under-vanity space. The unsealed floor penetration around a drain component in a wet room represents a plumbing condition that should be addressed to prevent moisture and pest ingress.

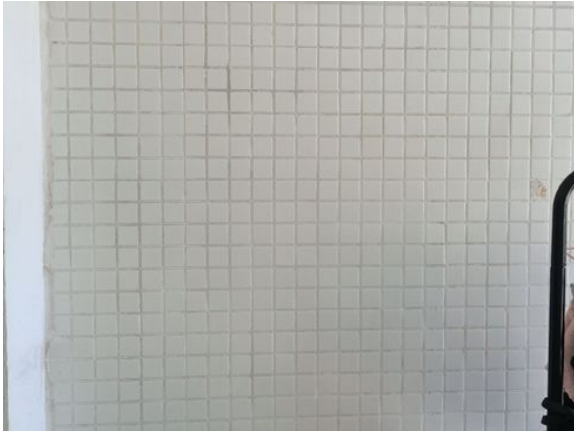
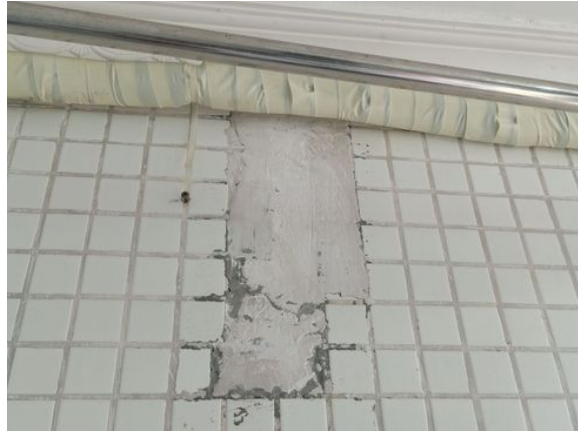
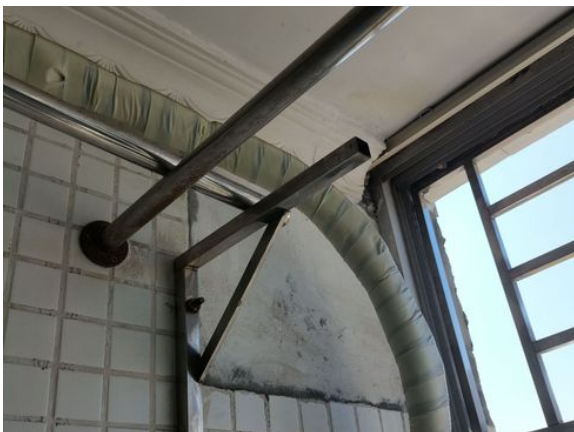
**North wall — missing tiles and exposed substrate**

The upper-right corner of the north wall shows a cluster of approximately nine missing wall tiles — roughly three tiles wide by three tiles tall — leaving the grey substrate exposed over the void. The grout at the perimeter of the missing area is disturbed and partially detached. The exposed substrate shows dark mottled staining consistent in appearance with possible moisture or biological growth. Missing tile at this location leaves the substrate unprotected and the staining on the backing material warrants investigation to determine whether moisture has penetrated behind the tile field.

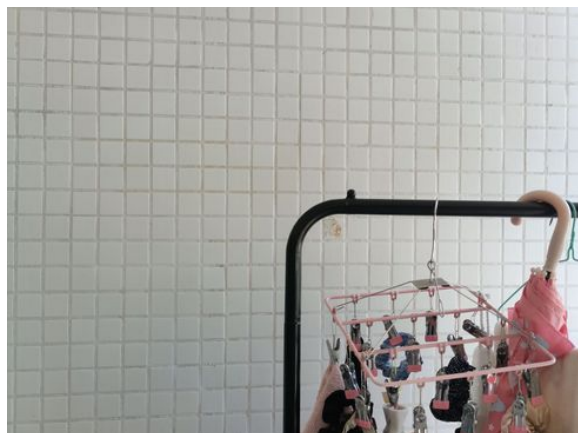
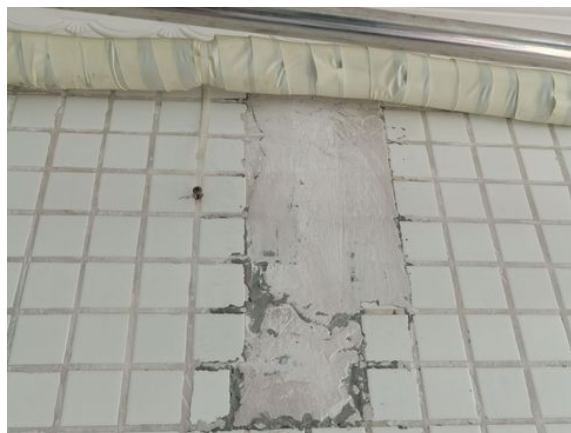
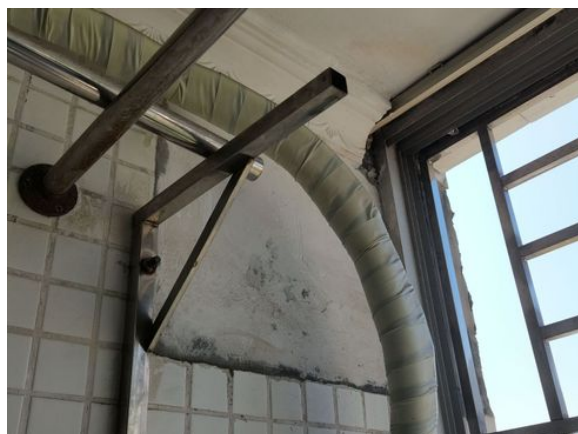
#### **South wall — missing tiles, biological staining, and corroded hardware**

The upper-left corner of the south wall shows a large cluster of missing wall tiles where adhesive failure has allowed the tiles to detach. Close-up documentation reveals dark grey-black biological staining on the exposed substrate across the missing area, a partially detached border tile at the perimeter, and corroded hardware in the same vicinity. The biological staining on the exposed substrate is consistent with prolonged moisture exposure behind the tile field and should be assessed by a qualified contractor before re-tiling.

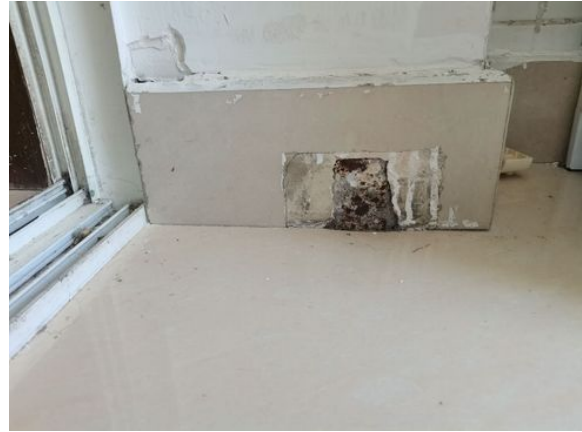
**Floor tile void and biological discoloration at the south wall base**

A floor tile at the base of the south wall is missing or displaced, exposing the substrate beneath. The exposed substrate shows dark discoloration consistent in appearance with biological growth. Peeling paint at the tile-to-wall junction in the same area is also documented. Missing floor tile in a laundry environment leaves the substrate directly exposed to water during appliance use, and the biological discoloration at the exposed area indicates moisture has already affected the substrate.

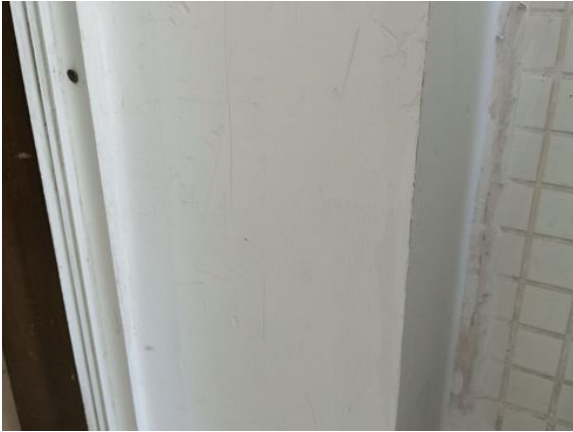
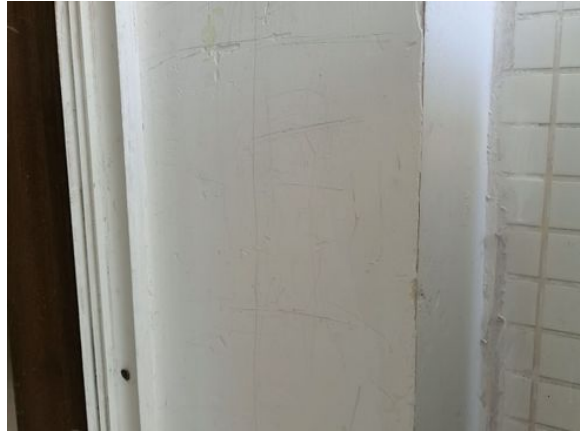
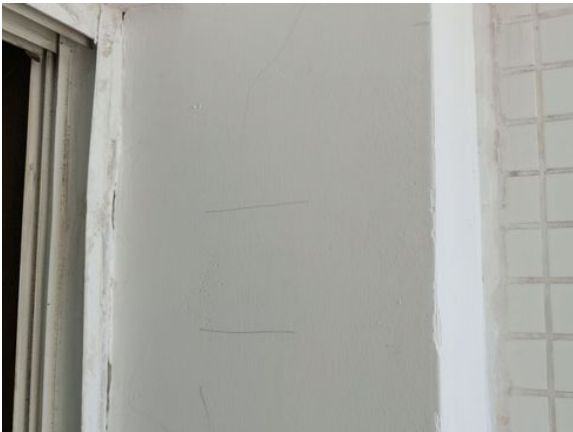
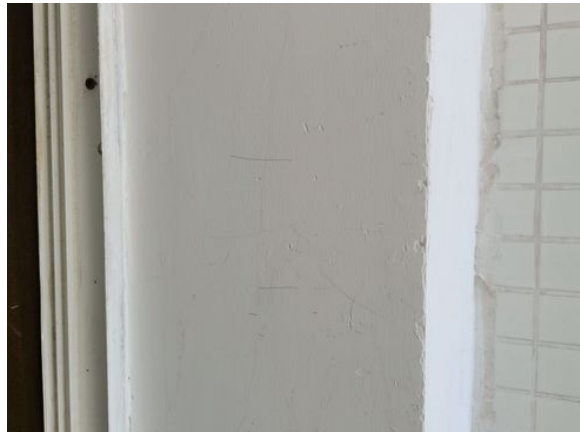
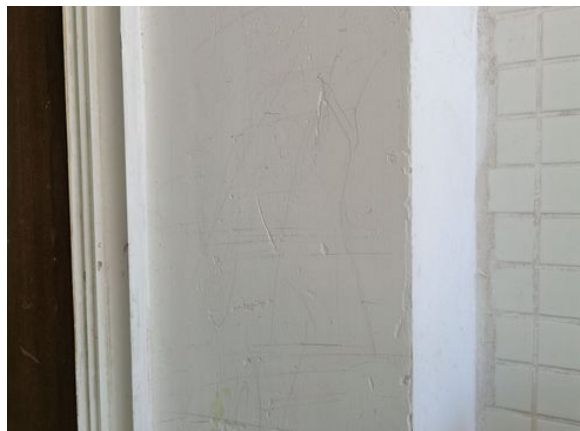
**Column drywall**

The column surface in the laundry room shows extensive scratches and gouges distributed across its full face. At the base of the column, material is missing and broken, with the substrate exposed at the column-to-tile junction. The column edges at the tile junction show chipping. Additionally, a door frame track component at floor level is displaced from its installed position. The missing structural material at the column base, combined with the displaced track component and the extent of surface distress, makes this the most complex single condition in the laundry room.

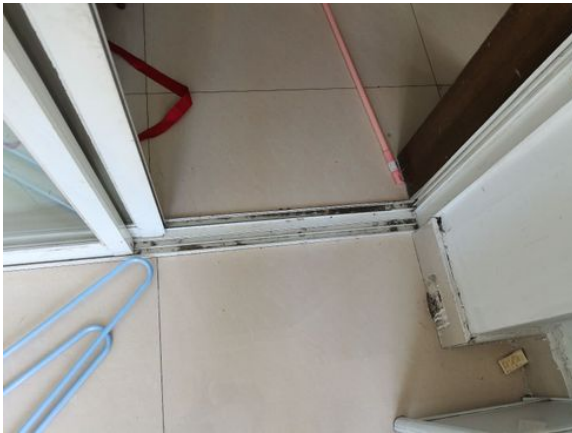
#### Entry threshold and door track

The entry threshold area shows biological-appearing accumulation in the channels of the sliding door track at floor level. The door frame base shows deteriorated and broken material consistent with prolonged moisture exposure. A floor-level electrical outlet is present in this area, and the surrounding wall shows signs of deterioration. Moisture-related deterioration of materials adjacent to a floor-level electrical outlet is a condition warranting prompt review.
