Property Inspection Report

**18939 Amherst Lane Evansville
Indiana 47725**

May 19, 2026

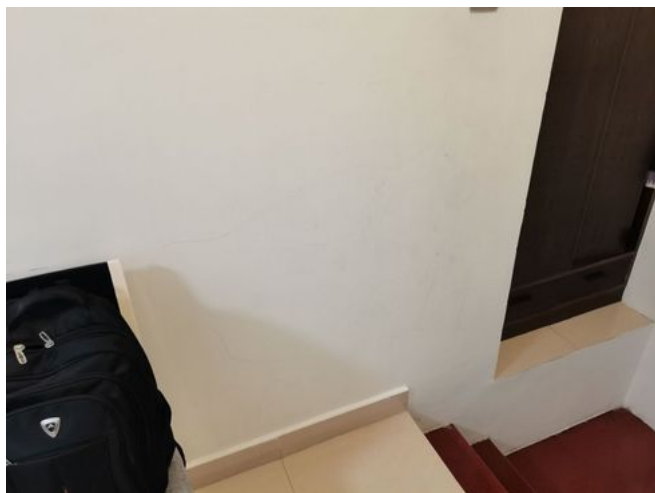
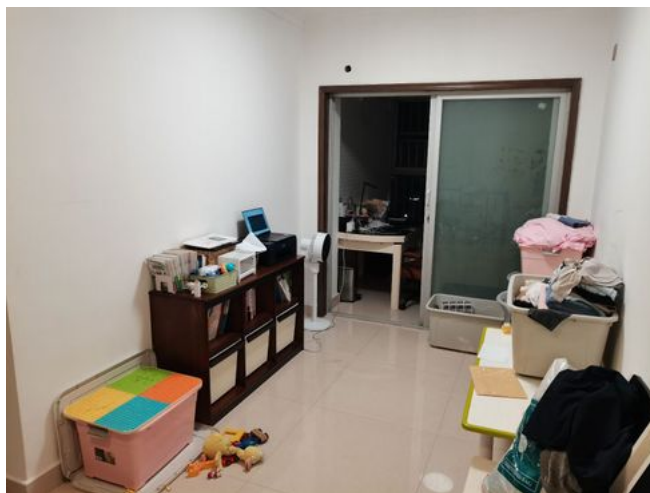
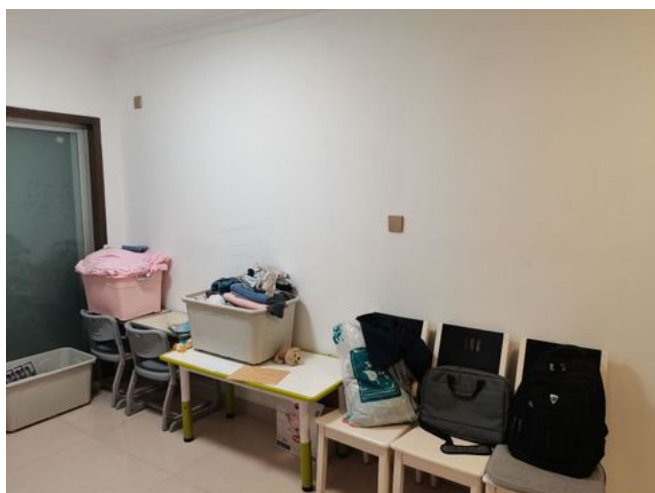
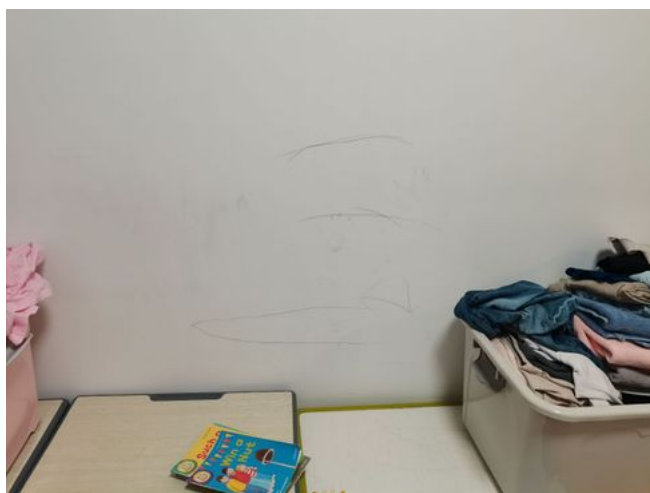
Living Room 1

The painted wall adjacent to the staircase area shows a cluster of pencil or pen drawings covering approximately 40–50 centimetres wide by 30 centimetres tall, with associated scuff and smudge marks extending around the drawn lines. The markings are at a height consistent with child-level reach and are clearly differentiated from the surrounding white painted surface. Scattered arc-shaped contact marks are also visible on the same wall section at mid-height, consistent with repeated surface contact.

A network of fine branching surface cracks spans approximately 50–60 centimetres in diameter on the painted wall near the built-in wardrobe. The cracks follow an irregular branching pattern consistent with paint or plaster cracking at the surface level. The extent of the affected area is notable and warrants documentation; the photograph was taken at an angle and captures a partial view, but the spread and character of the cracking are sufficiently visible to support this finding.

The painted wall adjacent to the sliding frosted glass door shows a darkened discoloration patch at mid-height, consistent with prolonged contact wear or moisture exposure. The same wide shot also reveals linear scratch marks on the back wall at a similar height, appearing as light streaks across the painted surface.

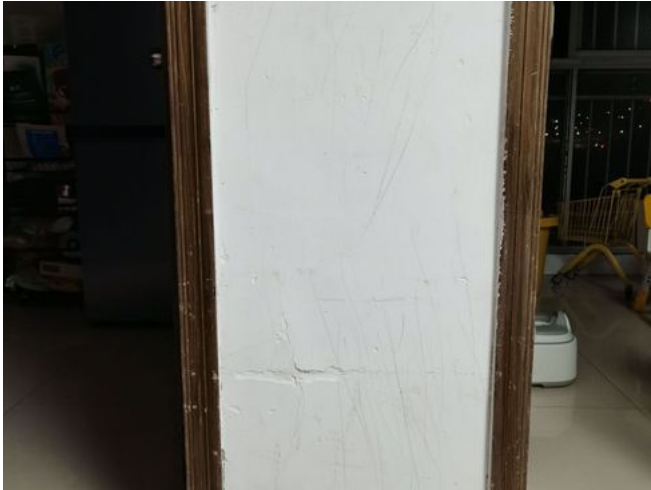
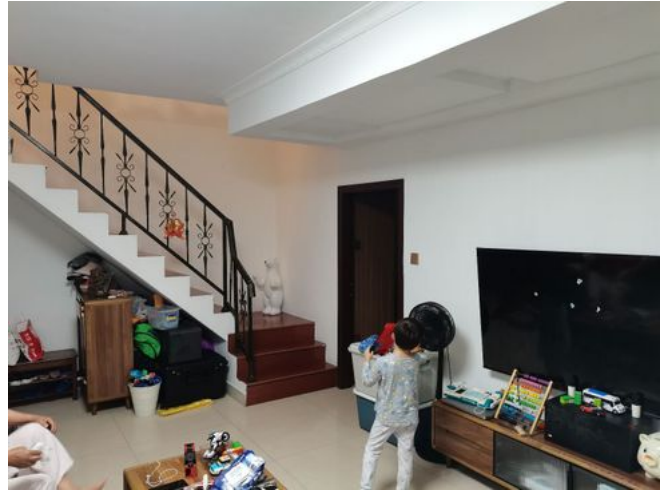
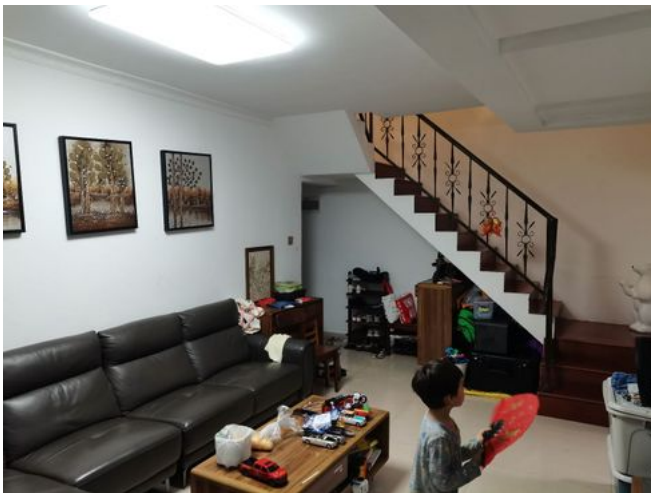
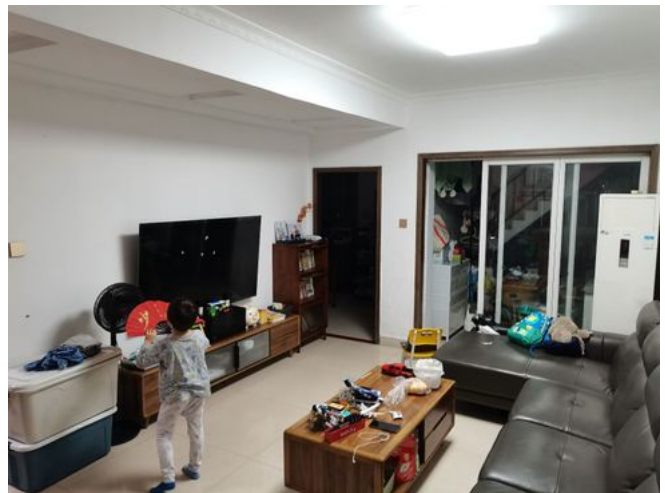
Living Room 2

The painted wall column between the door frames shows extensive scratch marks and surface gouges covering the majority of its face, from approximately mid-height to near the baseboard. The finish is visibly abraded and pitted across multiple locations, consistent with repeated physical contact or the dragging of objects against the surface. A lower-centre section of the same column shows an uneven, lumpy application of filler or patching compound, indicating a prior repair attempt that has not been finished to a smooth surface. Photograph quality in this group is affected by low-light conditions, but the extent of the marking and the patch texture are sufficiently legible to support documentation.

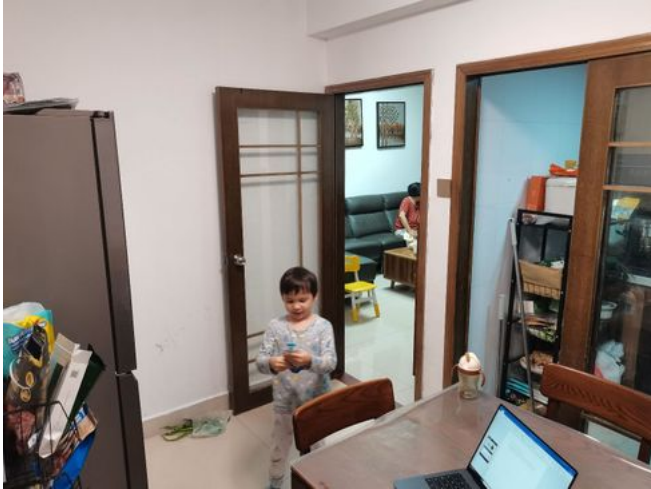
Dining Room

The painted wall surface between the two doorways shows extensive pencil and pen scribbles and markings across a broad area at mid-to-lower height. A close-up of the same area also reveals surface scratches, scuff marks along the baseboard, and an uncapped hole at the baseboard-floor junction where the wall meets the floor. The close-up photograph carries an extreme-angle flag that reduces ideal clarity, but the wide shot provides sufficient corroborating context to support all findings. The overall condition of this wall section represents a reportable cosmetic condition requiring remediation.

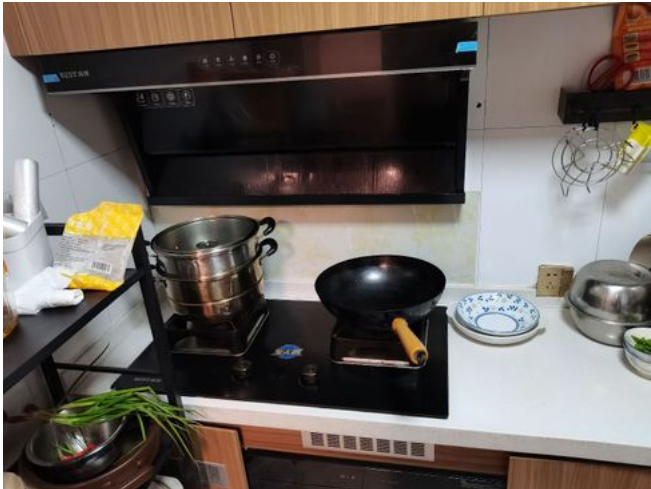
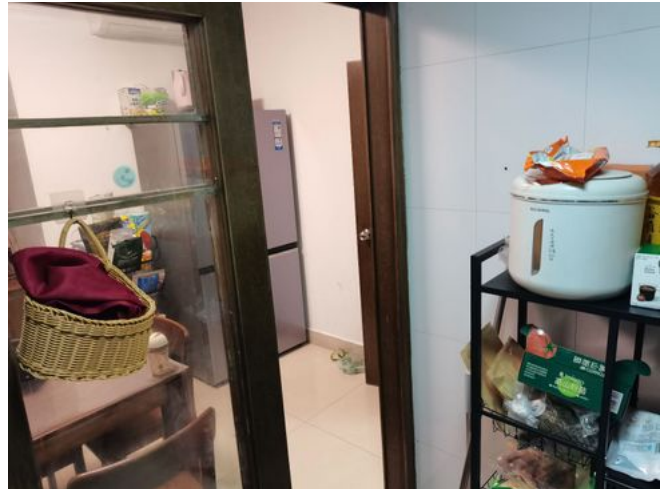
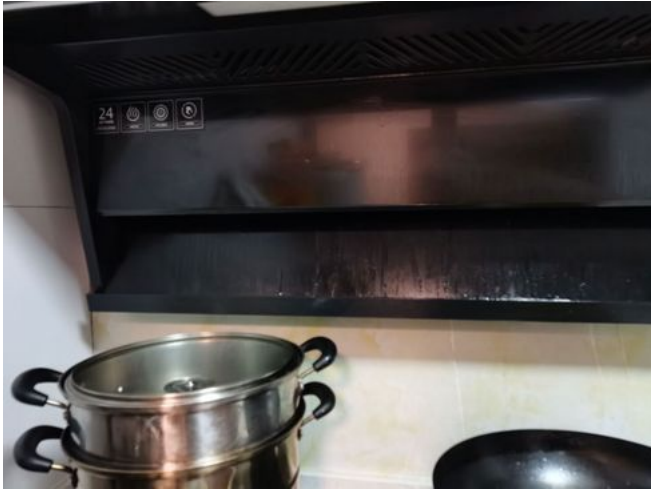
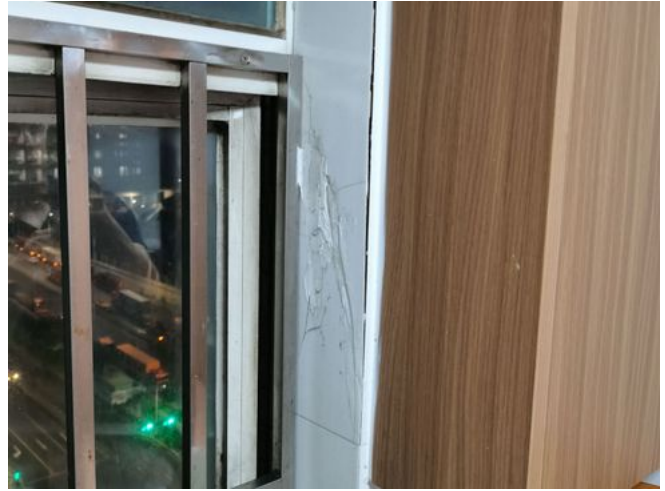
Kitchen

The range hood shows heavy grease and dark residue buildup across its interior baffles and on the underside lower shelf, with dried drip marks streaking across the full width of the shelf surface. White mineral or salt deposits are visible along the front edge of the hood shelf. The volume and character of the accumulation are consistent with extended cooking use without cleaning of the hood interior. One supporting photograph in this group is affected by blur, but the condition is established by the primary image.

The tile backsplash directly behind and around the range hood shows greenish-yellow discoloration across a broad area. The colour and distribution of this discoloration are consistent with either heavy grease accumulation or biological growth, and the condition warrants prominent documentation given its extent and potential health implications.

The tile wall surface between the window frame and the upper cabinet shows peeling and flaking of a white coating or sealant material across a vertical area approximately 20–30 centimetres in length, with the underlying tile exposed in patches. This pattern may indicate prior water ingress or a failed surface treatment. The photograph for this finding carries low-light, partial-view, and extreme-angle quality flags, which limit evidentiary reliability, but the condition is identifiable within the available image.

The window security bars show generalised surface corrosion and rust staining across multiple bars and frame joints, consistent with prolonged moisture exposure. The condition is distributed across the bars rather than confined to a single point, suggesting an established and ongoing process. A vertical pipe or conduit at the base of the wall column between the window and the upper cabinet also shows surface rust and discolouration along its visible length; photo quality flags limit the clarity of this observation but the condition is identifiable.

The ventilation grille panel on the lower cabinet unit beneath the stove appears displaced or misaligned, with a visible gap at its base where it meets the cabinet frame. Blue adhesive tape is affixed to the front upper edge of the range hood, which may indicate an unremoved repair patch or protective covering that has not been addressed.

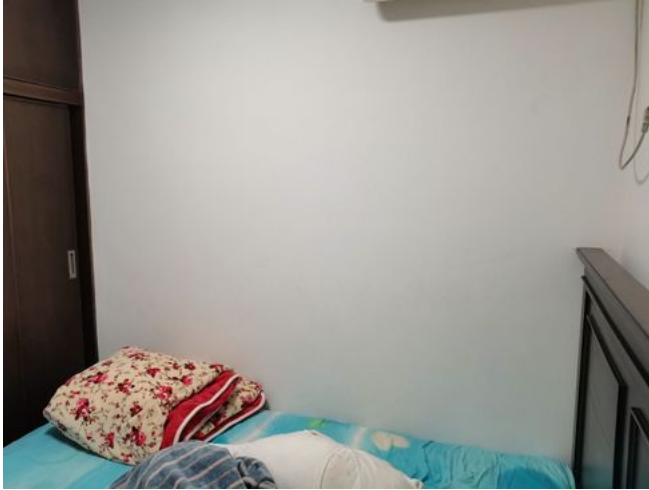
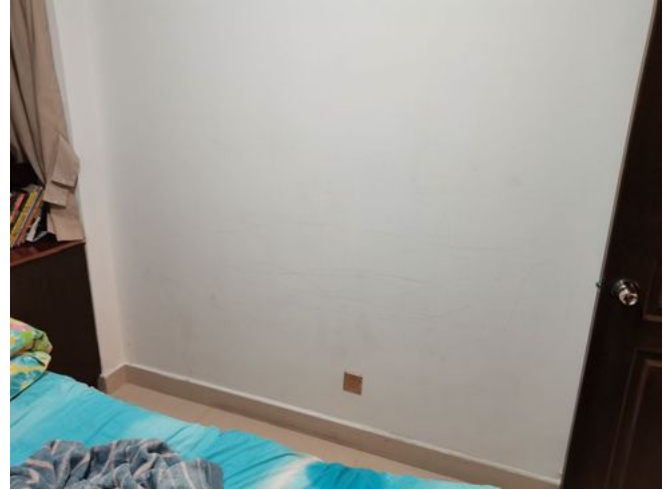
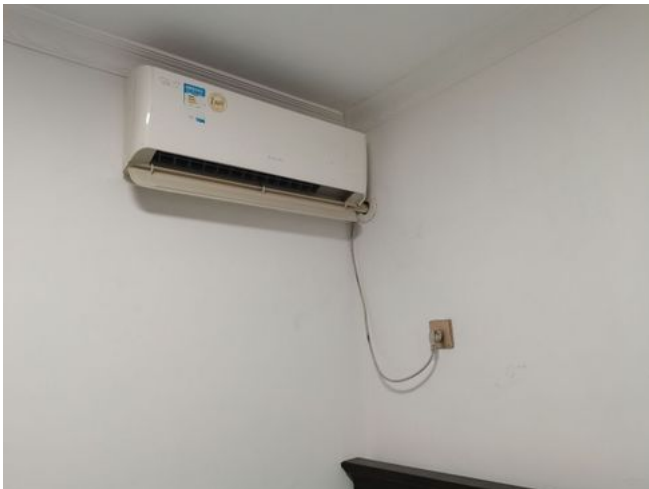
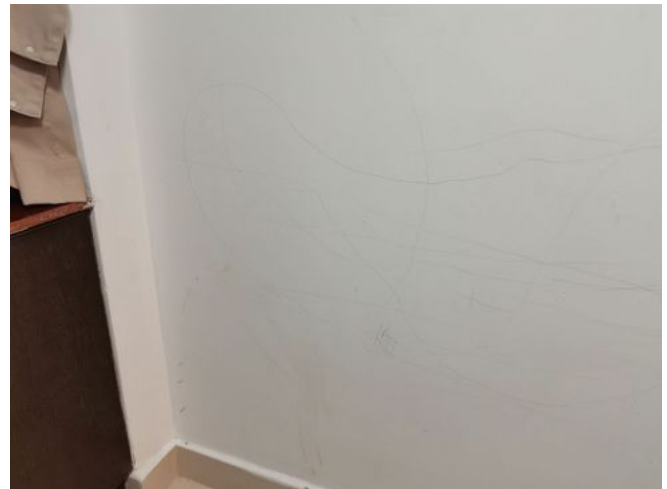
Bedroom 1

The wall opposite the entry door shows multiple fine horizontal cracks spanning approximately two-thirds of the visible wall width at mid-height. The cracks are distributed across a broad section of the painted surface and are consistent with surface-level settlement or paint stress. Given the extent and the location on a prominent wall, this finding warrants prominent documentation.

An exposed HVAC power cable runs unsecured down the wall surface for approximately 60–70 centimetres from the HVAC unit to the outlet below, with no conduit or cable management securing it to the wall. This condition is documented across a wide establishing shot and two close-up photographs that confirm both the cable routing and its connection points. A separate HVAC drain or refrigerant hose runs along the upper wall from the unit toward the window area in an unsecured and loosely routed arrangement.

Pink and red crayon or marker markings span approximately 40–50 centimetres across a white painted wall surface at mid-height, forming curved and angular outlines. Separately, extensive pencil or pen line markings cover approximately 80–100 centimetres wide and 40–50 centimetres vertically across another painted wall surface, representing a distinct and reportable cosmetic condition on a second wall.

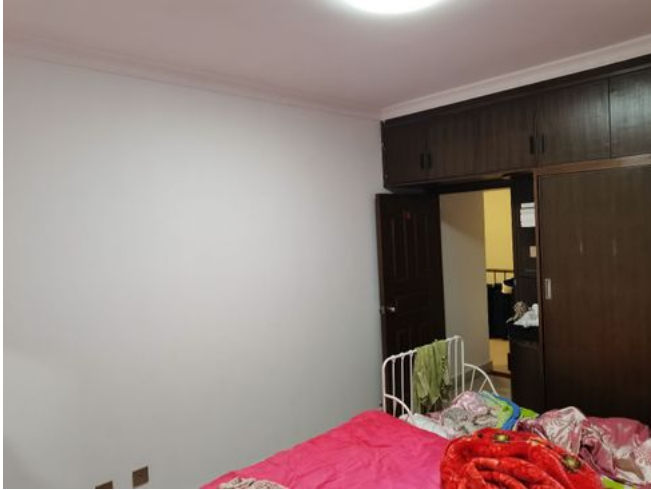
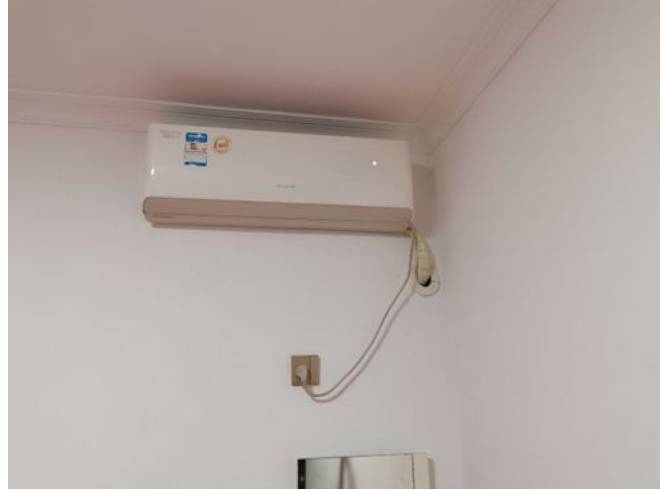
Bedroom 2 was documented with four photographs across three wide shots and one close-up, and the survey phase was completed with three walls covered. Curation of this room's photos did not produce main-body finding groups. The available photos are retained in the appendix. Conditions identified in the structured data but not yet closed out with dedicated close-ups include a faint ceiling discoloration patch near the flush light fitting, an unsealed wall penetration at the HVAC cable exit point, low-mounted electrical outlets whose mounting condition was not confirmed, a gap or misalignment at the upper junction of the wardrobe above the doorway, and a broad area of possible surface repair or uneven sheen on the wall opposite the entry. These represent undocumented conditions that were visible in the wide shots and should be noted as documentation gaps.

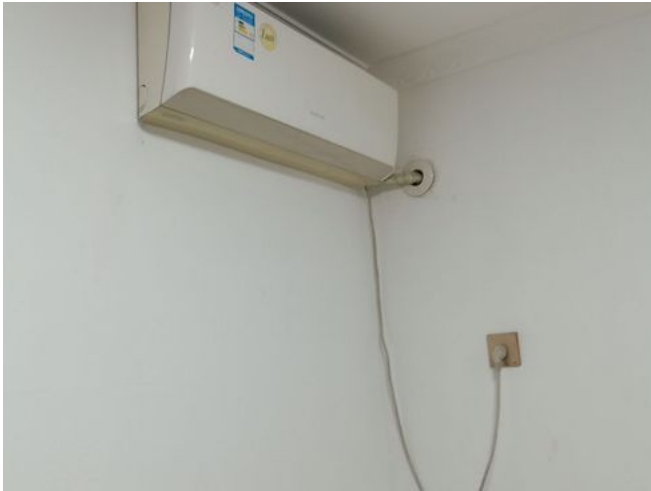
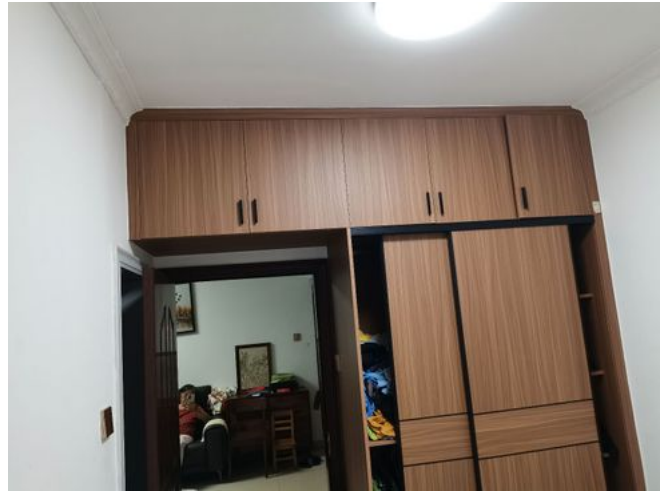
Bedroom 3 was documented with five photographs and survey phase was completed with three walls covered. Curation of this room did not produce main-body finding groups. The appendix photos are the primary record for this room. Conditions identified in the structured data but not closed out include extensive crayon or marker markings and written characters covering approximately 80–100 centimetres wide and 60 centimetres tall at mid-to-lower wall height on one wall, pencil or pen markings and scrawled marks on the wall opposite the entry, possible wardrobe door track or alignment issues, and an HVAC unit with a yellowed lower louvre panel and minor surface scuffing around the wall penetration. These represent undocumented conditions that the survey-phase photographs detected and should be noted as documentation gaps.

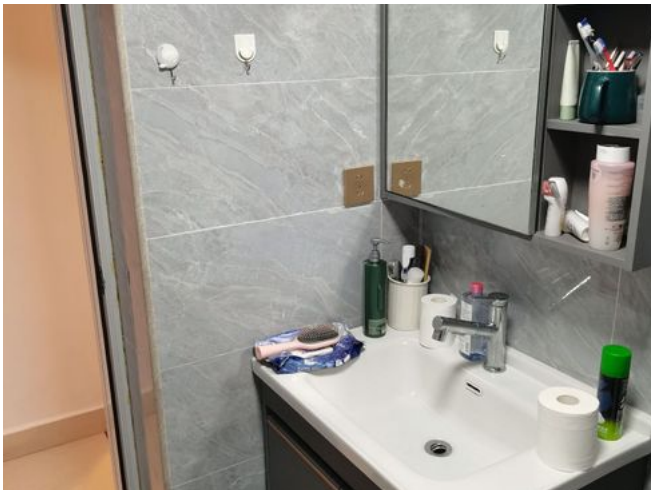
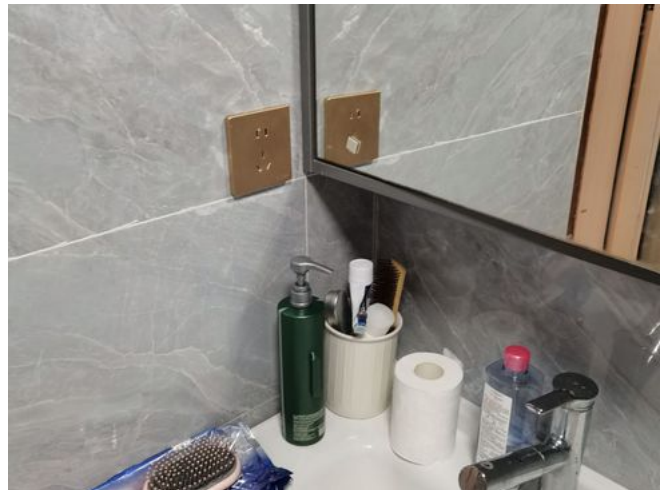
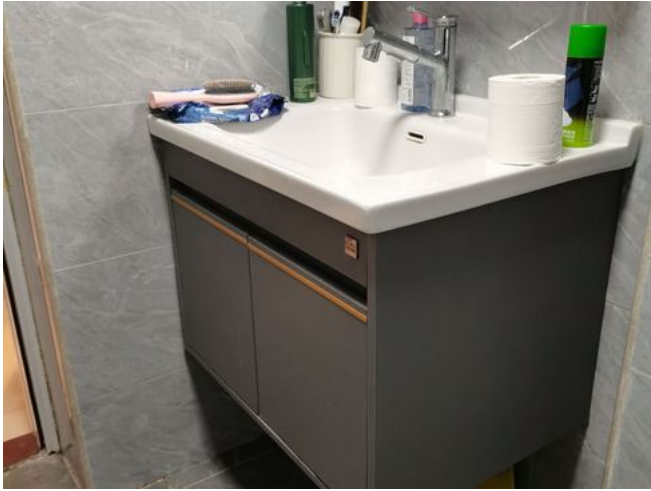
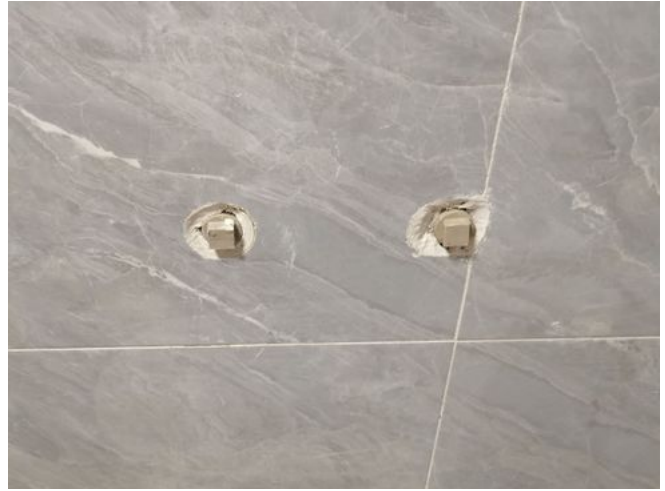
Bathroom 1 was documented with six photographs. Survey phase was completed with three walls covered. Curation did not produce main-body finding groups, and the photos are retained in the appendix. Conditions identified in the structured data but not closed out at the focus level include rough, chipped tile cutouts around the shower valve penetrations with no escutcheon plates and inconsistently applied white filler at the edges, floor grout discoloration distributed across multiple locations, a gap at the door frame-to-tile junction at lower left, two adhesive wall hooks on the tile surface whose removal may affect the tile finish, and an unclear window condition with metal security bars and possible obstruction of the glazing. These represent conditions visible in the available photographs that were not captured with dedicated close-ups.

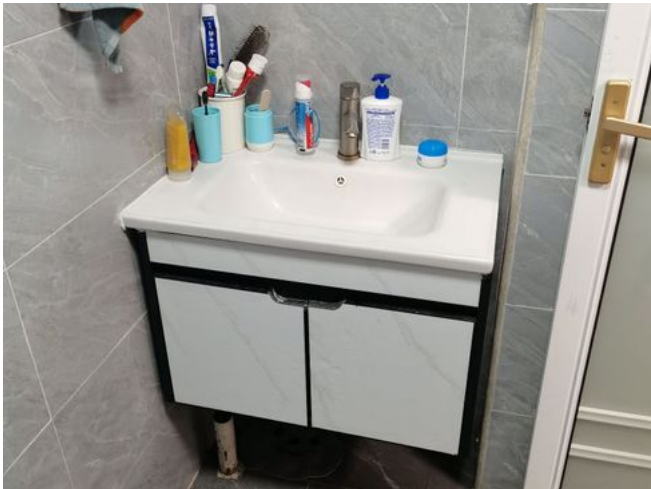
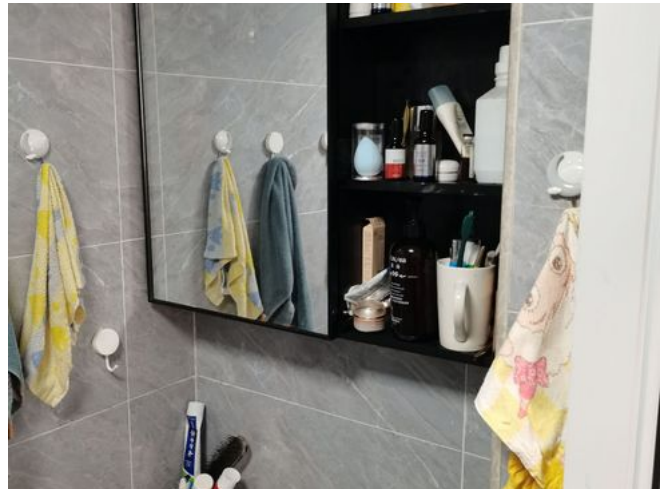
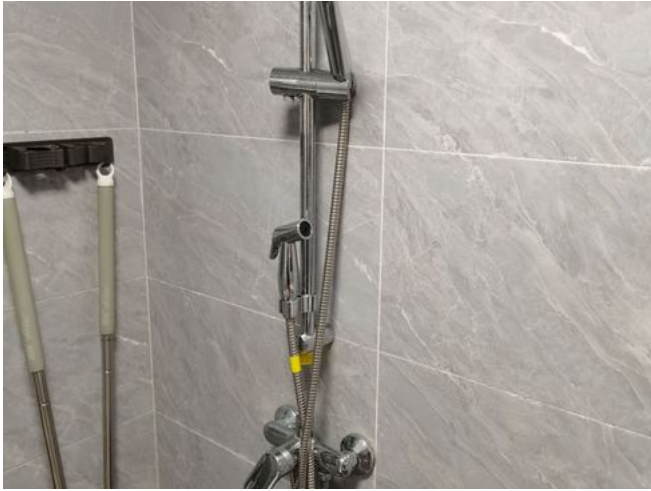
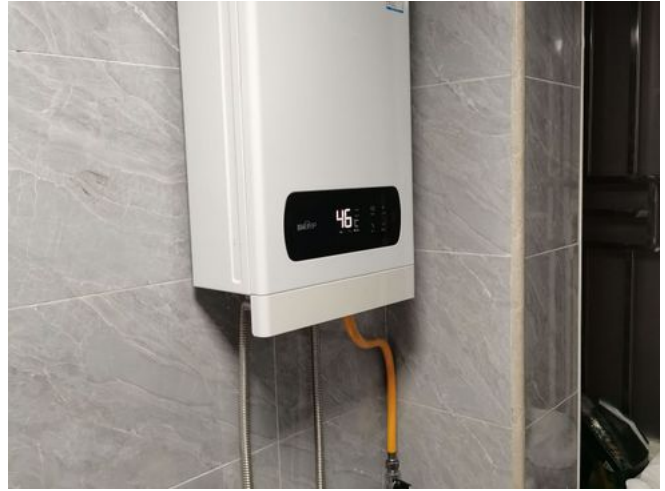
Bathroom 2

The shower area, as observed from the doorway, appears to lack a defined enclosure or water containment screen adjacent to the toilet area. The absence of a visible enclosure barrier means the wet zone is open to the surrounding floor area. Floor grout discoloration is also visible at the shower base in the same wide shot.

The wall-mounted gas water heater presents two conditions that warrant documentation as health and safety signals. An orange flexible gas supply hose runs exposed from the heater base down the wall to the floor-level shut-off valve, without a protective sleeve or securing bracket, and with an unsupported mid-run bend. Additionally, the flue duct penetrating the ceiling at the top of the heater shows what appears to be an unfinished gap around the duct at the ceiling junction, with no clearly visible sleeve or bracket securing the penetration. Both conditions warrant review against applicable gas installation standards.

The recessed alcove behind the shower screen shows visible surface corrosion and oxidation staining on the metal security bar window frame and multiple bar members, consistent with prolonged exposure to a wet environment. The photograph was taken under low-light conditions but the condition is sufficiently legible to support documentation.

The vanity area shows a corroded and stained exposed drain pipe below the cabinet at floor level, with dark residue visible on the pipe surface. The sealant at the base of the vanity cabinet shows an uneven and partially separating condition against the adjacent wall tile. Floor grout discoloration first identified in the wide shot is also confirmed in this close-up.

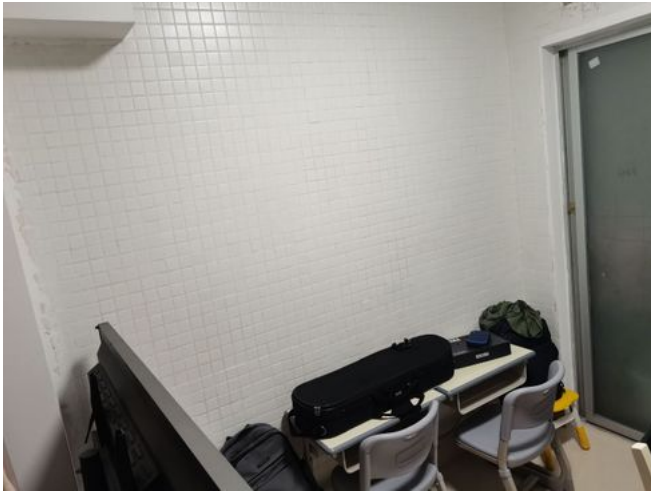
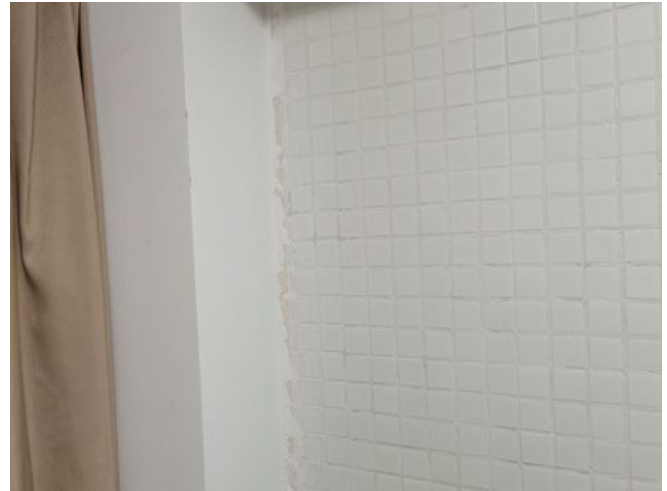
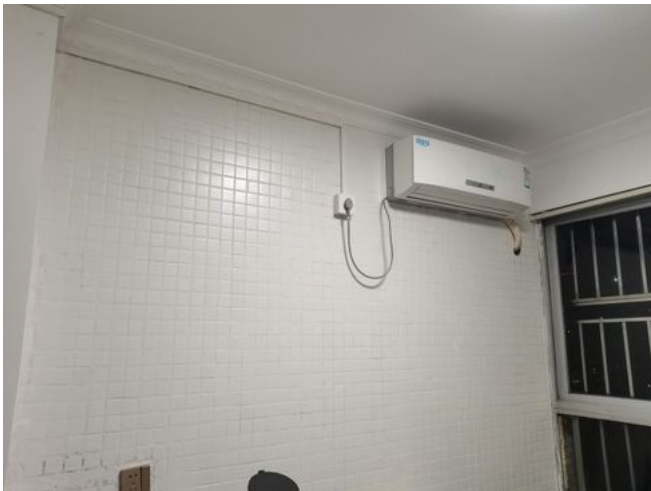
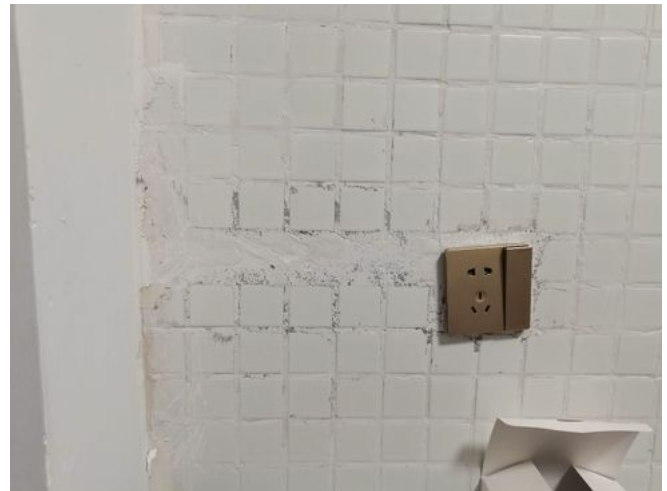
The Office was documented with six photographs across two wide shots and four close-ups, with survey phase completed and three walls covered. Curation did not produce main-body finding groups. The appendix photos are the primary record for this room. Conditions identified in the structured data include tile surface coating delamination and bubbling across approximately 40 by 30 centimetres on the wall with the window, dark discoloration and disturbed grout surrounding an electrical outlet on the same wall, an HVAC hose terminating loosely near the window frame without a proper wall penetration, writing or markings on the painted wall adjacent to the sliding door, soiling or adhesive residue on the sliding glass door panel, discoloration on the underside of the built-in overhead shelving, an irregular plaster or patch finish at the vertical corner junction between the plain and tiled walls, and a taped conduit or pipe arrangement on the floor creating a potential trip hazard. These represent significant undocumented conditions that the structured data identified but dedicated close-ups did not capture.

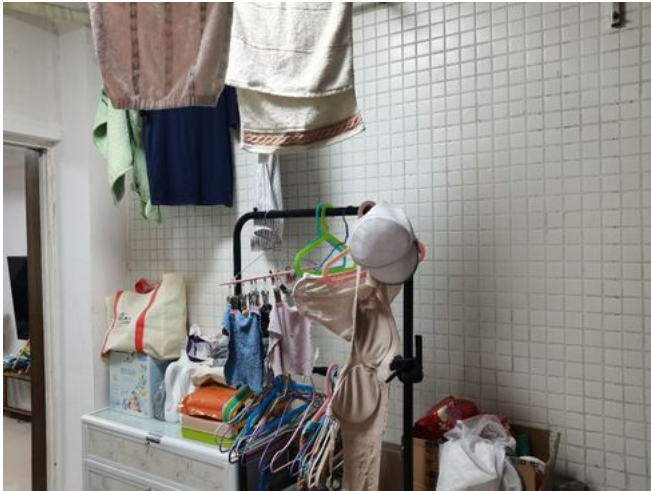
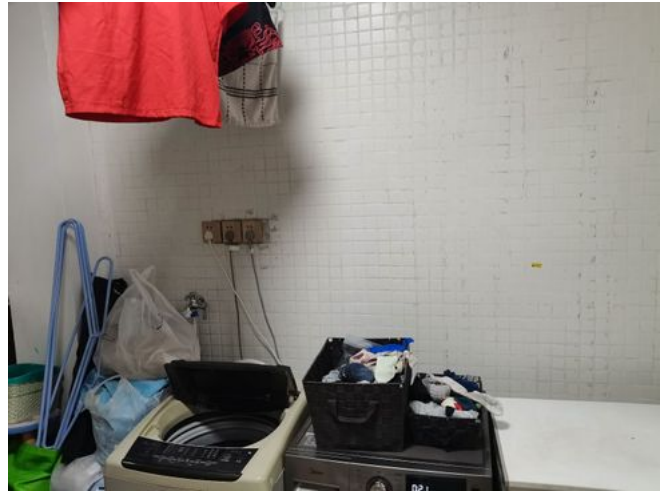
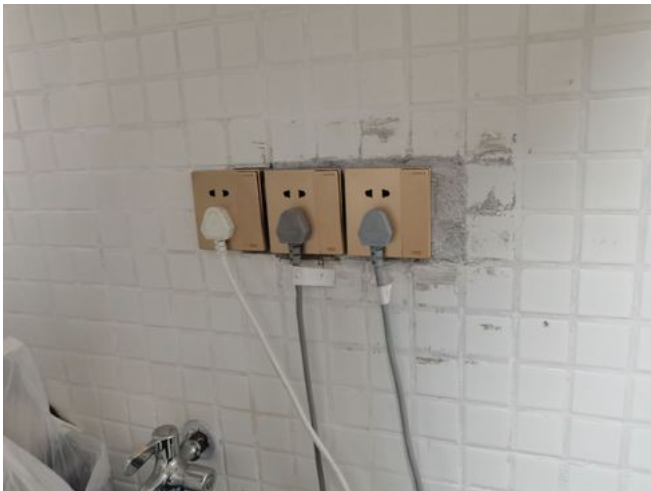
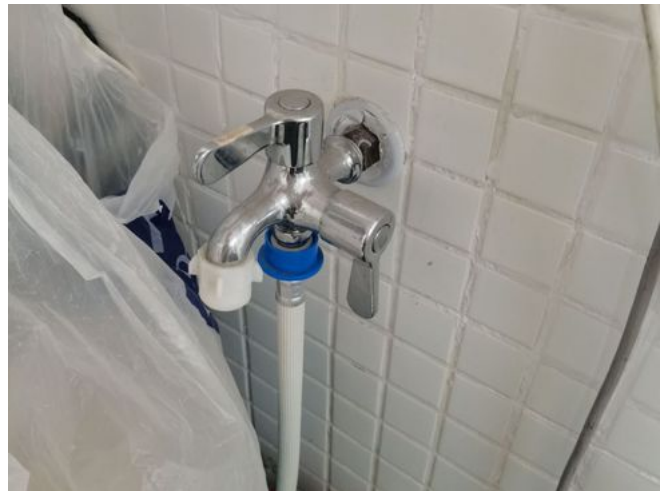
Laundry Room

The main tiled wall shows large dark staining around the plumbing connection area, spanning approximately 30–40 centimetres vertically above and around the plumbing stub-out. The staining pattern and extent are consistent with prolonged moisture exposure, possible water ingress, or chronic leaking at the plumbing connections. Grout lines in the surrounding mosaic tile field show corresponding discoloration. A corroded and deteriorated cover plate at the plumbing connection point is visible in the close-up, with the surface showing significant surface breakdown.

The three-outlet cluster on the tiled wall shows tile surface coating delamination extending across approximately 30–40 centimetres wide and 20 centimetres tall around and to the right of the outlets, exposing the grey substrate and adhesive layer beneath. The outlets are installed directly over this compromised surface, and unsecured surface-run cables exit the outlet cluster without conduit or cable management. The combination of surface failure at an electrical installation point and unprotected cabling represents a condition warranting documentation as a health and safety concern.

The wall-mounted washer tap fitting shows visible tarnishing and surface corrosion on the chrome body and spout, with the finish appearing pitted and discoloured across multiple areas of the fitting. Additionally, the escutcheon or backplate behind the right-hand valve stem appears absent or incomplete, leaving a visible gap and a partially exposed

wall penetration around the valve supply stub.

The wall-to-ceiling junction behind the clothes-hanging rail bracket at the upper left of the room shows darkened residue and spotting consistent in appearance with mold or organic growth. The low-light conditions in this photograph reduce absolute certainty, but the pattern and location of the marking — at a ceiling junction in a room with documented moisture-related conditions elsewhere — are sufficient to support documentation at high significance. This finding warrants follow-up to determine whether active moisture ingress or biological growth is present.
