# Property Inspection Report

**300 Chestnut Way, Apt. 1B  
Sacramento, CA 95814**

**October 26, 2026**

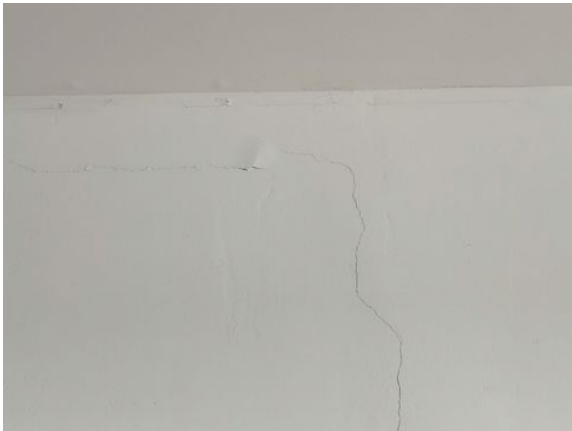
**West wall below the light switch**

The west wall below the light switch presents several overlapping crack conditions across a localised area. A pronounced diagonal hairline crack runs toward the corner where the wall meets the door frame, and additional horizontal cracking is present at the wall-ceiling junction with visible paint separation. At the base of the wall near the door frame, a gap with exposed substrate is visible where the wall surface has pulled away from the framing. The concentration and variety of crack orientations in this area — diagonal, horizontal, and at the base — are consistent with ongoing or prior movement at this wall section.

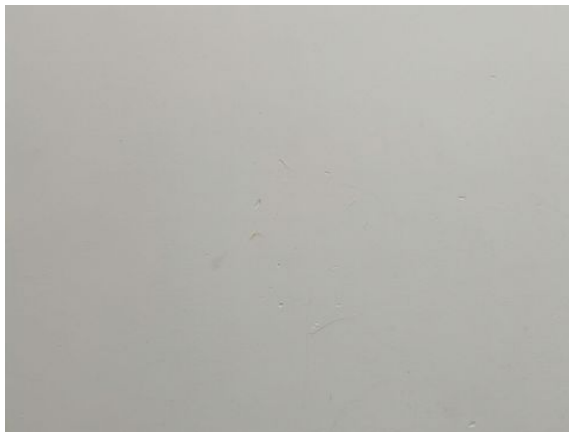
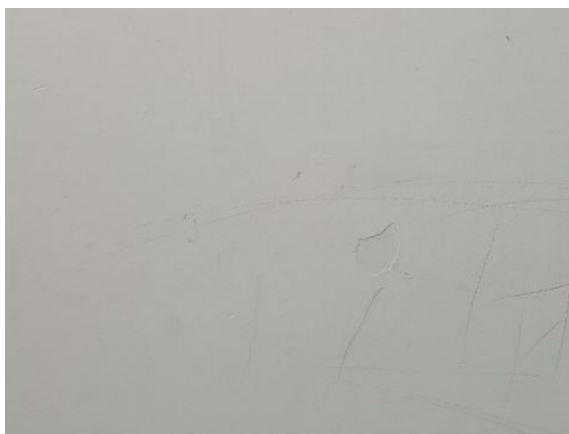
**North wall above the sofa**

The north wall surface directly above the sofa position shows a concentration of surface distress including multiple scratches, gouges, and surface abrasions where the paint layer has broken. In one location, a section of wall material appears raised or torn, with lifted material at the edge. Deliberate red marker or crayon markings in letter-like shapes are visible on the same wall surface, accompanied by scuffs and irregular lighter-toned areas that appear consistent with prior touch-up attempts that did not fully conceal the underlying markings. The combined area of distress spans a section of the wall directly accessible from the sofa position.

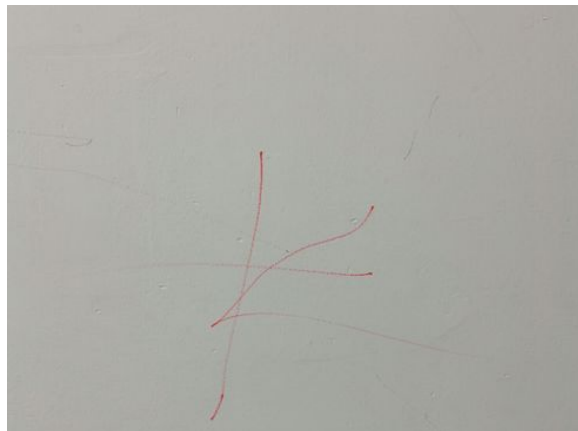
#### **North wall above the sofa — red markings**

A separate concentration of deliberate markings on the north wall above the sofa shows red pen or marker strokes forming recognisable letter-like shapes. The surrounding area shows scuff marks and irregular patches where the surface tone differs from the general paint finish, suggesting that attempts have been made previously to address similar markings in this location. The markings are distinct from incidental scuffs and appear intentional in character.

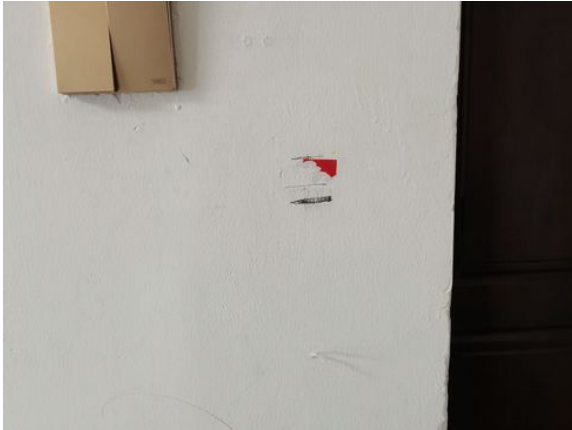
**Wall beside the apartment entrance**

The wall surface adjacent to the apartment entrance shows a combination of conditions: red and black pen or marker writing, crayon markings, adhesive sticker residue, and nail holes are all present across the surface. The area around the light switch also shows imperfect patching, visible as a slightly raised or discoloured section of the wall face. The adhesive residue and nail holes indicate prior fastening of items to this surface, and the markings span a broad section of the entry wall at a height consistent with access from standing height and below.

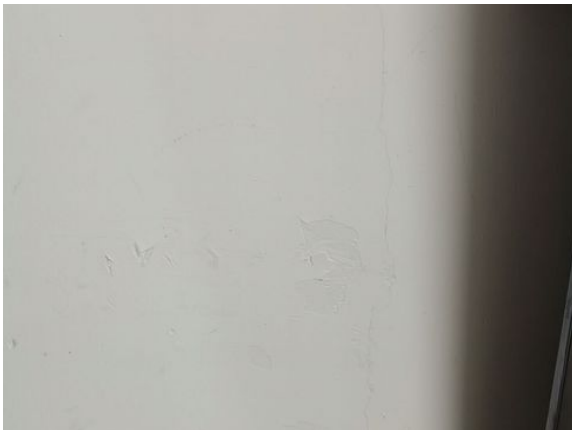
**East wall beside the TV**

The east wall beside the TV position shows a vertical crack running from the ceiling junction downward, with lifted and flaking paint material along its length. In addition to the crack, multiple scuffs and surface gouges are present on the same wall section. The crack originates at the ceiling-wall junction and follows a largely vertical path, with the paint failure concentrated along the crack line itself. The surrounding surface shows general scuffing consistent with contact at furniture height.

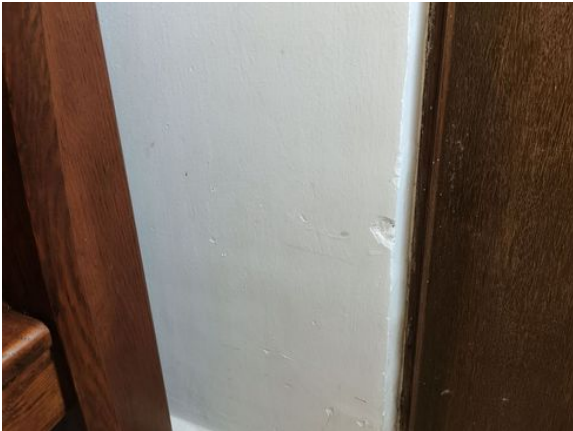
#### **South wall — markings, puncture voids, and impact gouges**

The south wall documents several overlapping conditions. Puncture voids are present where material has been driven into the wall surface, and impact gouges with missing surface material are visible at multiple locations. The wall corner edges show deterioration at the arris, with the corner bead material compromised. Across a broad area of the same wall surface, red and pink crayon or marker drawings are present, covering a substantial proportion of the visible wall face. The deliberate markings and the impact damage appear independent of one another and together represent a range of conditions requiring remediation.

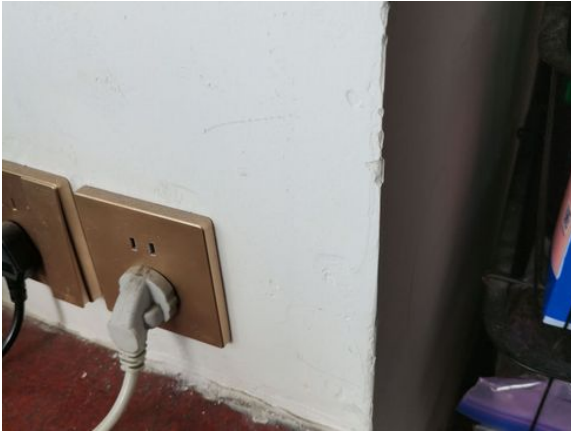
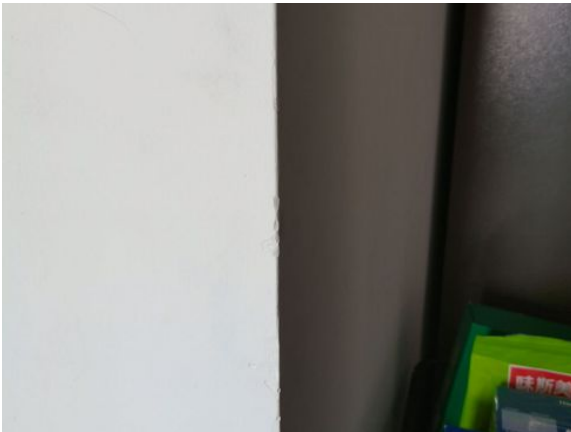
**Wall corner near the kettle area**

The vertical corner bead along the wall corner nearest the kettle position shows chipping, crumbling, and missing surface material along its full vertical length. White debris consistent with disintegrated corner bead material is visible on the countertop surface below. The deterioration appears active rather than historic, in that loose material is present rather than a previously stable exposed edge. This corner will require replacement of the corner bead and associated patching before the surface can be repainted.

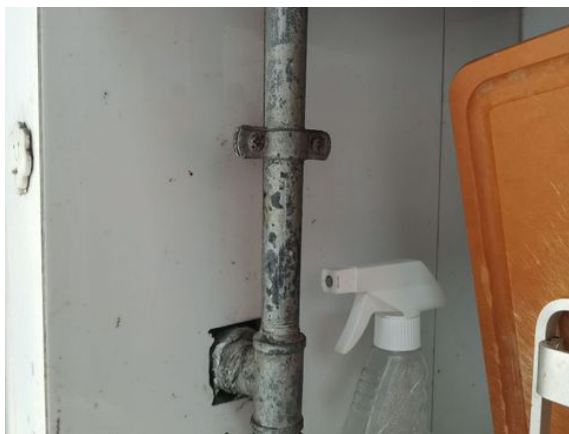
**Exposed gas pipe and wall penetration**

An exposed gas pipe in the kitchen shows extensive surface corrosion along its visible length. The wall penetration through which the pipe passes is unsealed and shows deteriorated finishing material around the opening, leaving the gap between the pipe and wall surface open. A yellow flexible gas connector passes through a hole in the countertop that has no collar or protective sleeve, and the countertop opening itself is unfinished. Additionally, an electrical outlet cover plate in the same area is missing or damaged. Taken together, the corroded gas pipe, the unsealed wall penetration, the uncolored countertop gas connector pass-through, and the compromised outlet cover constitute multiple conditions warranting immediate attention from qualified tradespeople. No cause is assigned here, but these conditions should be reviewed by a licensed plumber and electrician before the unit is occupied.

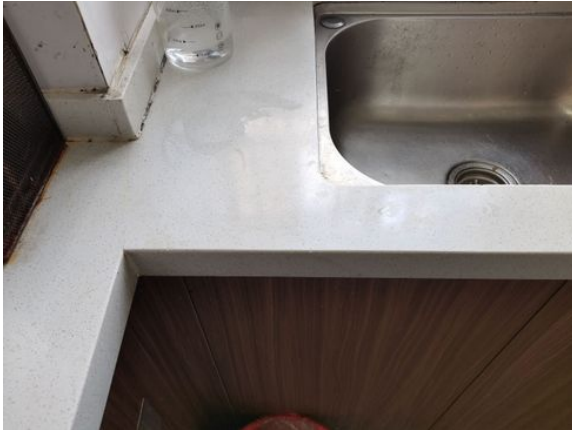
### Wall-countertop junction and sink area

At the left rear corner of the countertop, extensive dark spotting is present along the wall-countertop junction, consistent in appearance with biological growth. The caulking at the sink perimeter appears degraded and has lost its sealing integrity in this area. A metal mesh fixture in the sink area shows rust staining. The biological growth pattern is concentrated at the joint between the wall and countertop where moisture is most likely to accumulate, and the degraded caulking may be contributing to ongoing moisture access at this junction.

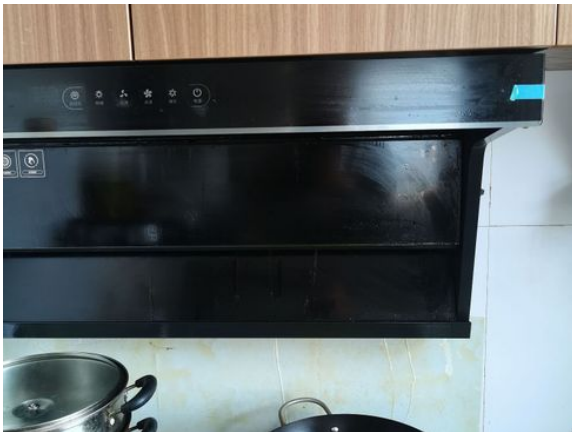
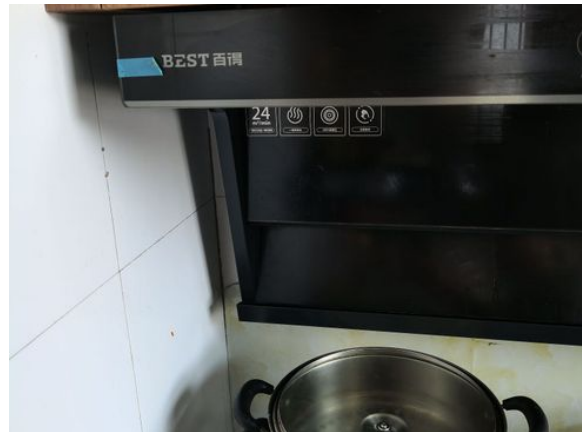
### Range hood and backsplash buildup

The interior baffles and grille of the range hood are coated with a heavy layer of grease residue across their full width. The buildup is thick and distributed uniformly, indicating extended use without cleaning of the hood's filtration components. The tile backsplash behind the stove extends approximately 60 centimetres and shows widespread yellowed and greenish-brown grease staining across most of its surface. The staining is heaviest immediately above the cooking surface and diminishes toward the top of the tiled area. These conditions are consistent with extended cooking use without regular cleaning of the affected surfaces.

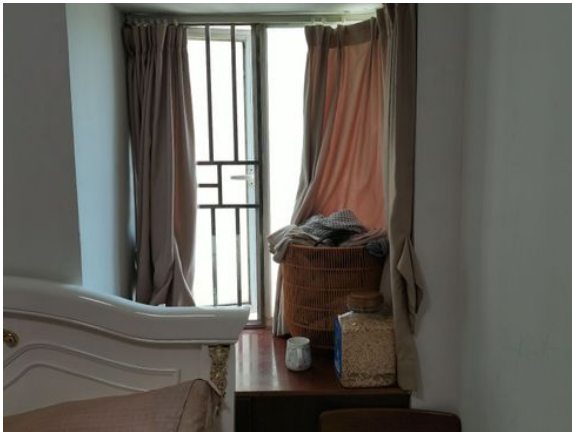
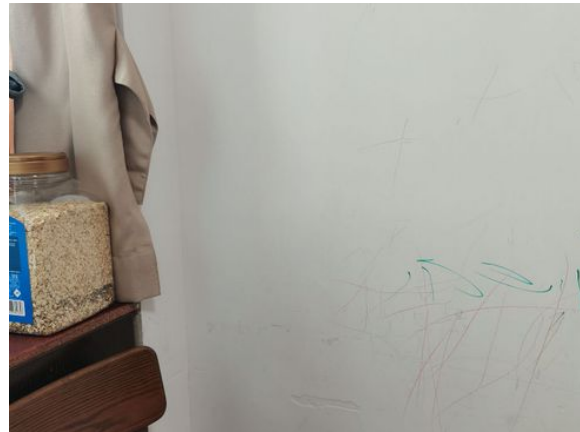
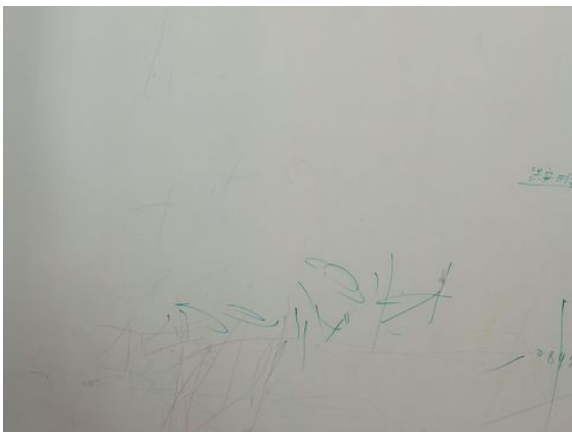
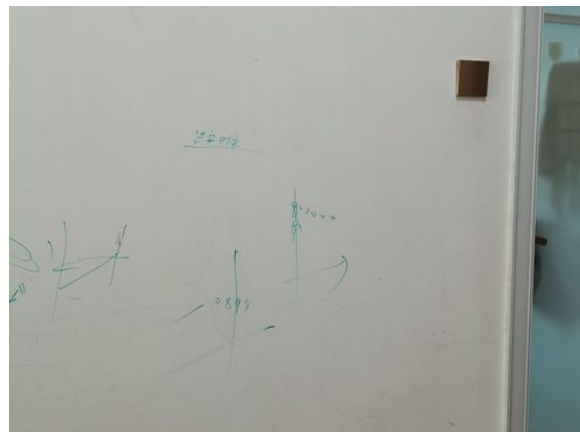
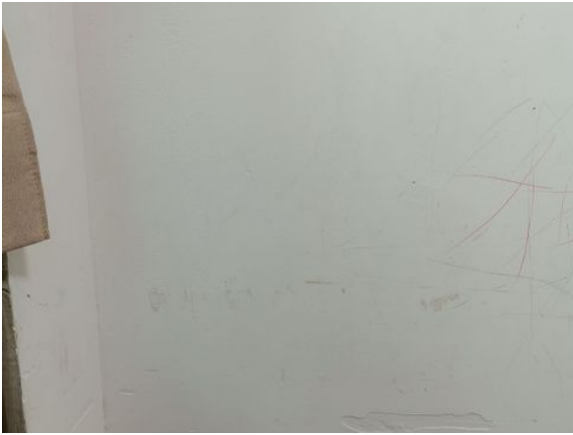
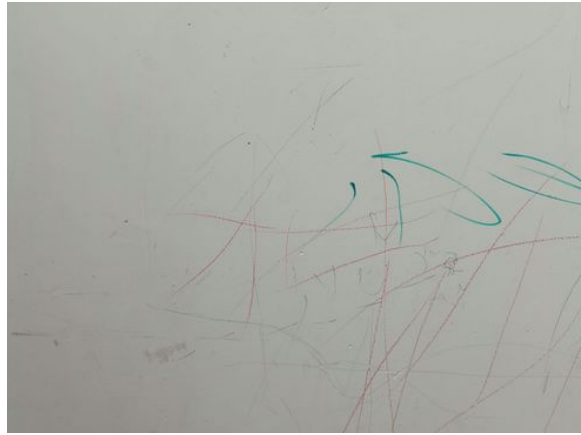
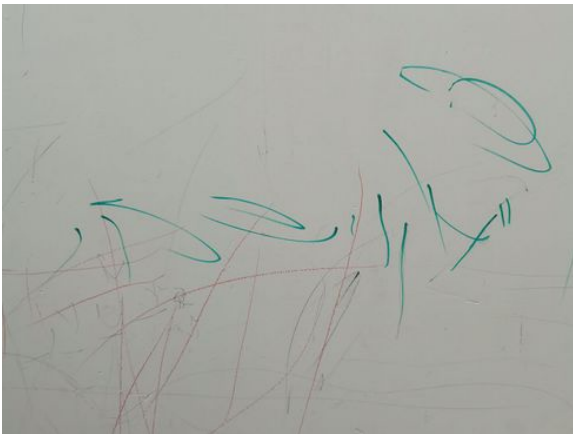
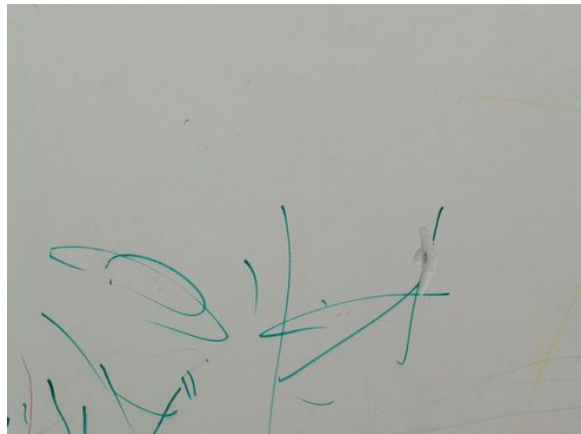
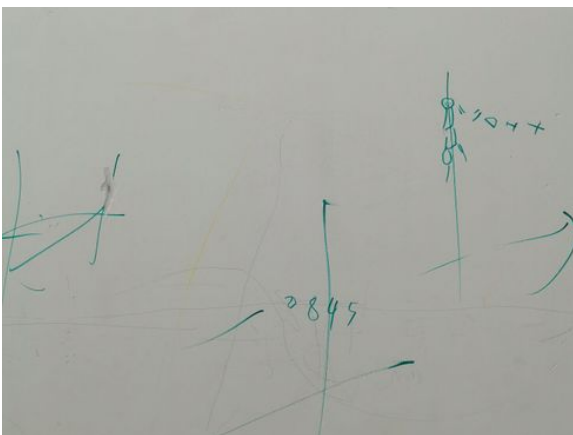
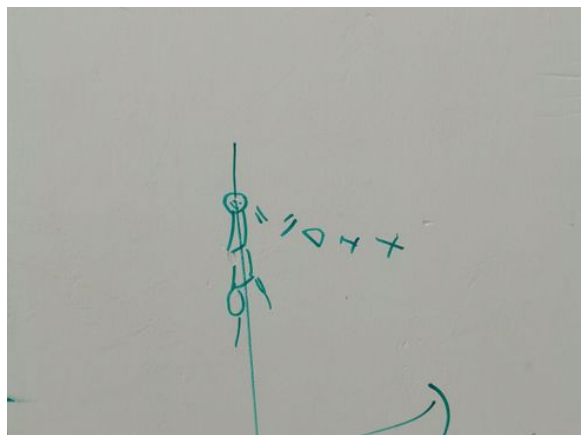
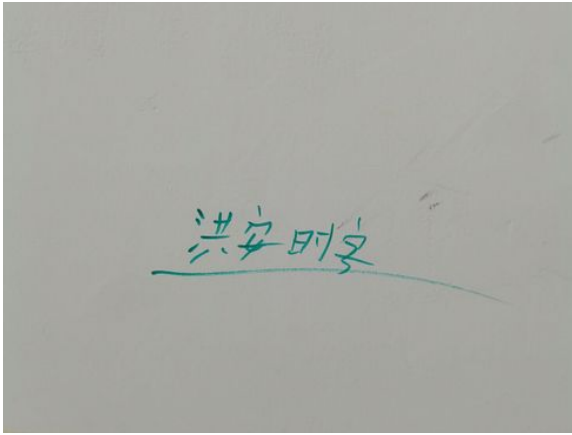
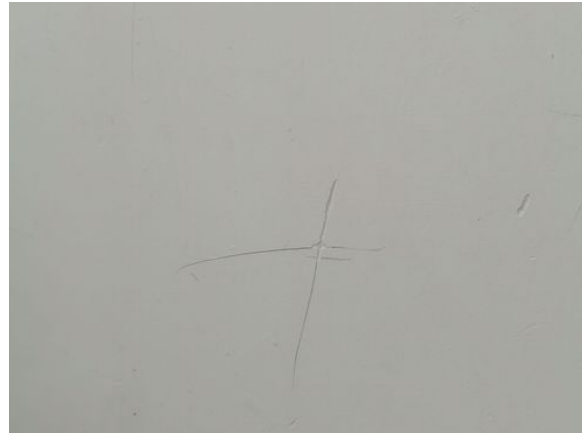
**South wall — crayon, marker, and pen markings**

The south wall lower section shows extensive deliberate markings in multiple colours — red, green, teal, and yellow — covering approximately 0.5 to 0.8 square metres of wall surface. The markings include crayon strokes, marker lines, and pen marks applied at heights consistent with access by a young child. Fine linear scratches are also present on the upper section of the same wall surface above the marking zone. The extent and variety of the markings across this area indicate repeated application over time and will require redecoration to address fully.

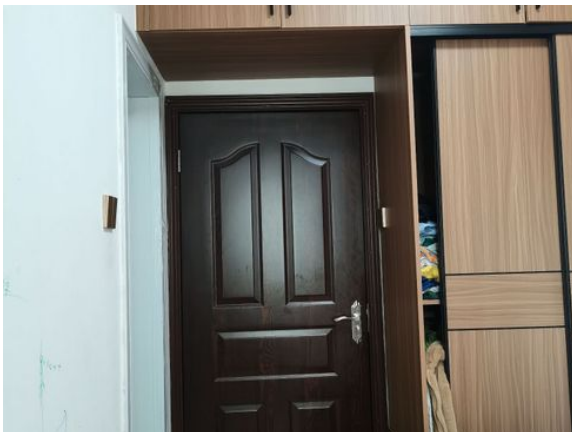
#### **West wall near the north corner**

Green crayon and pen markings, including drawn figures and text, cover approximately 0.3 to 0.4 square metres of the west wall lower-to-mid section near the north wall corner. The markings share the character of those documented on the south wall and are applied at a similar height range. This constitutes a separate surface requiring redecoration in addition to the south wall.

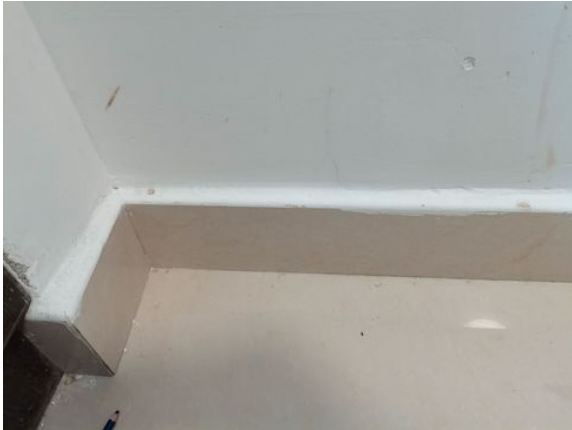
**Baseboard condition**

The baseboard along at least one wall of this room shows an unfinished or unpainted face, with peeling and flaking paint along the top edge that exposes the substrate beneath. Protruding fastener hardware is visible at multiple points along the board. These conditions are consistent with a baseboard installation that is either incomplete or has deteriorated to the point that the paint and finish have failed. The exposed substrate and protruding fasteners indicate the baseboard requires remediation beyond ordinary cleaning or touch-up.

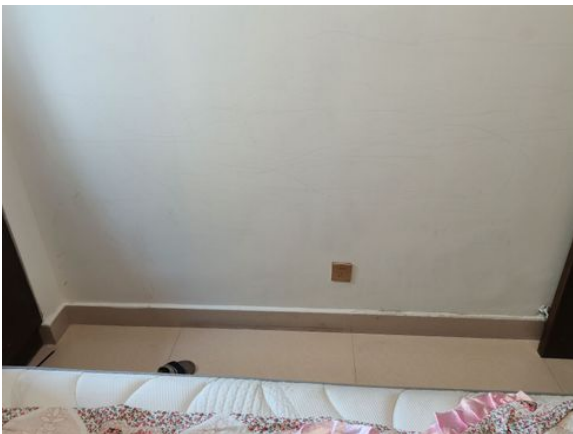
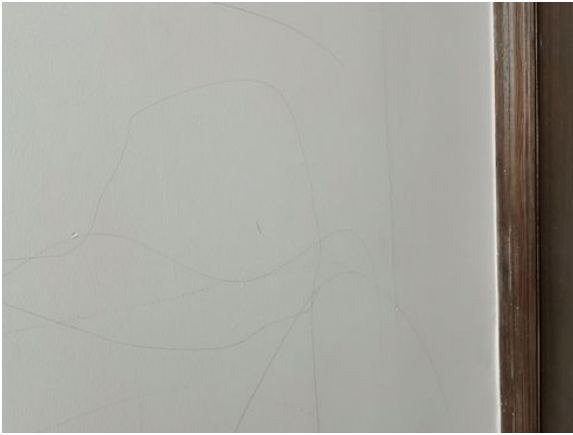
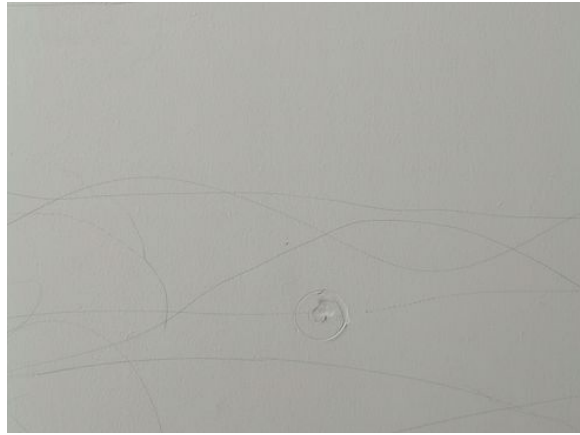
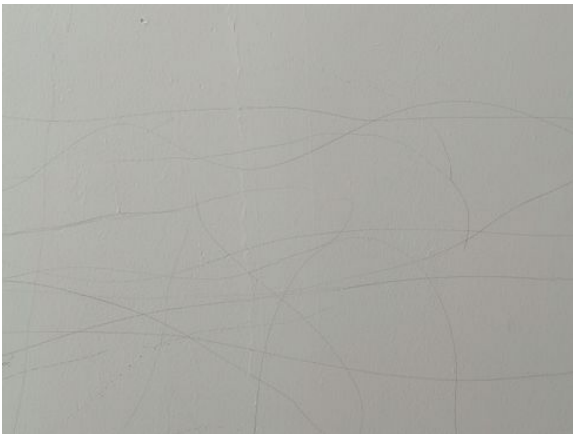
**North wall — curvilinear scratch markings**

The north wall painted drywall surface shows extensive curvilinear fine-line scratch markings spanning most of the wall width at mid-height. The marks follow sweeping, repetitive curved paths across the painted surface and extend over a large proportion of the wall face. A small blue mark is also visible in the same area. The character and distribution of the scratch markings are consistent with repeated contact with an implement across the surface over time, rather than isolated incidental contact.

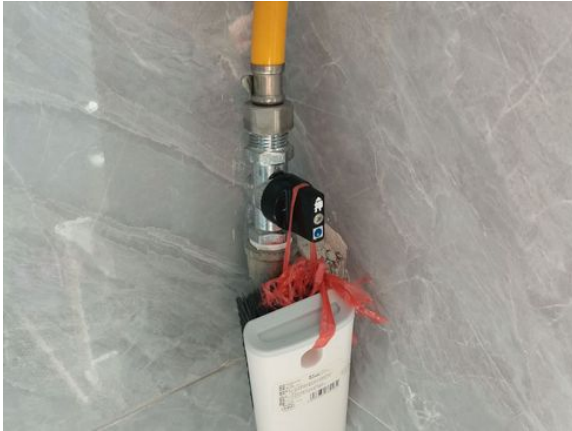
### **Gas supply line routing**

An exposed gas supply line is present in the bathroom without adequate wall finishing at its penetration point, leaving an incomplete opening around the line where it enters through the wall. At floor level, an electrical cord and water supply lines are co-routed in direct contact with the gas line. Corrosion is visible at the valve fittings. The co-routing of an electrical cord and water lines in contact with a gas supply line, combined with the corroded fittings and unsealed wall penetration, represents multiple conditions that should be reviewed by a licensed plumber and electrician. No cause is assigned, but the combination of utilities in direct contact warrants professional assessment.

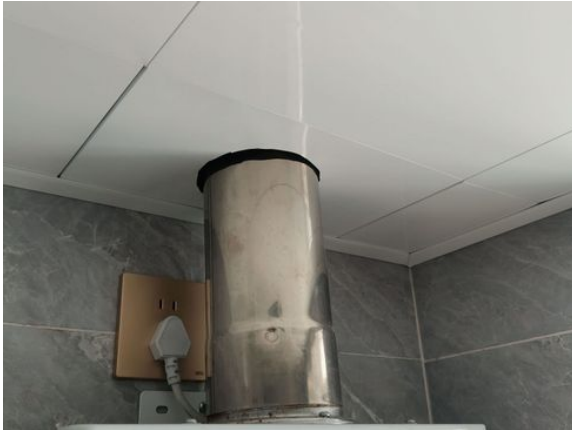
### Water heater flue penetration

The ceiling penetration where the water heater flue exits the bathroom shows informal tape and sealant material used in place of a compliant collar. A crack is present in the ceiling surface at the penetration point, and corrosion is visible at the base of the flue where it connects to the appliance. An unsealed or improperly sealed flue penetration on a gas appliance vent is a condition that should be reviewed by a qualified technician. The ceiling crack at the same location may indicate movement or stress at the penetration.

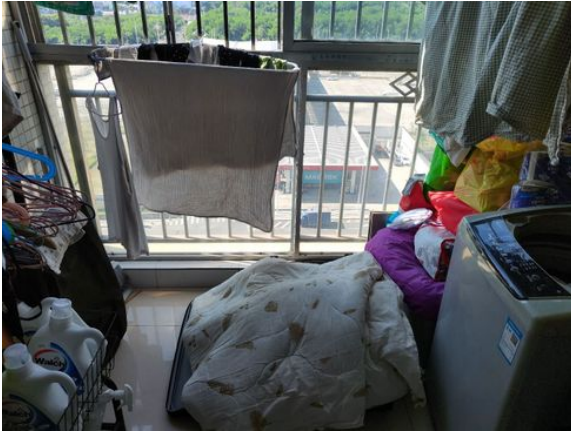
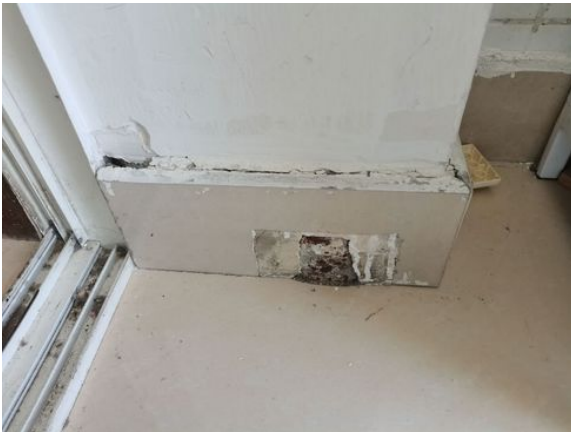
**Floor tile void and biological discoloration at the south wall base**

A floor tile at the base of the south wall is missing or displaced, exposing the substrate beneath. The exposed substrate shows dark discoloration consistent in appearance with biological growth. Peeling paint at the tile-to-wall junction in the same area is also documented. Missing floor tile in a laundry environment leaves the substrate directly exposed to water during appliance use, and the biological discoloration at the exposed area indicates moisture has already affected the substrate.

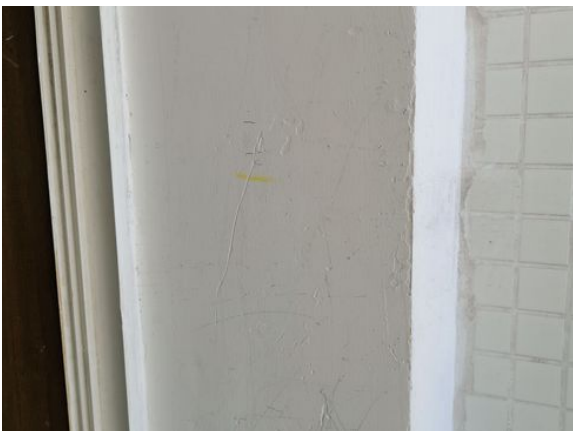
**Column drywall**

The column surface in the laundry room shows extensive scratches and gouges distributed across its full face. At the base of the column, material is missing and broken, with the substrate exposed at the column-to-tile junction. The column edges at the tile junction show chipping. Additionally, a door frame track component at floor level is displaced from its installed position. The missing structural material at the column base, combined with the displaced track component and the extent of surface distress, makes this the most complex single condition in the laundry room.

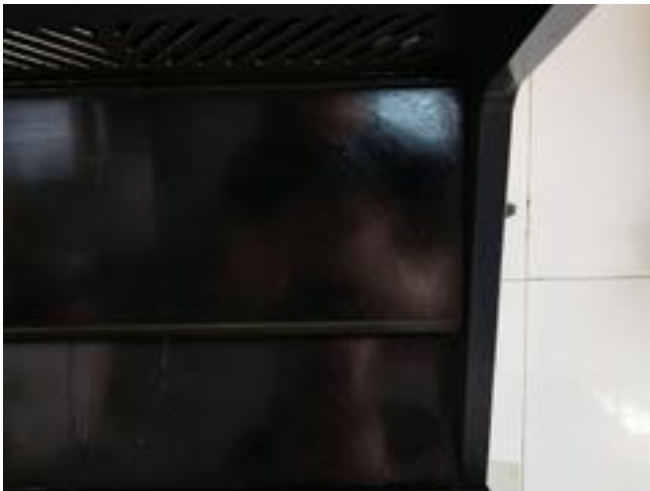
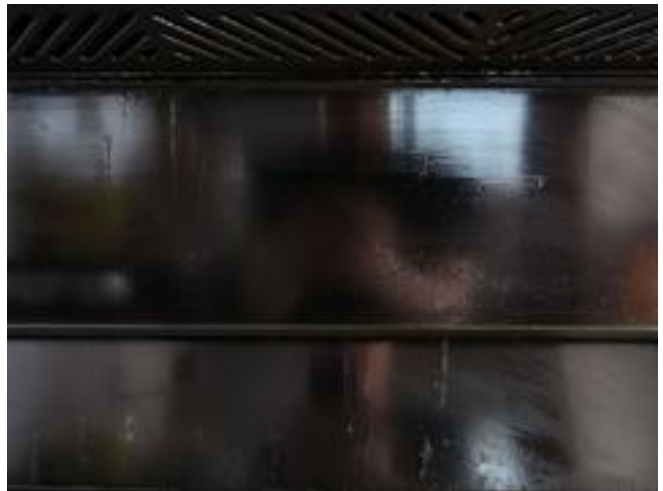
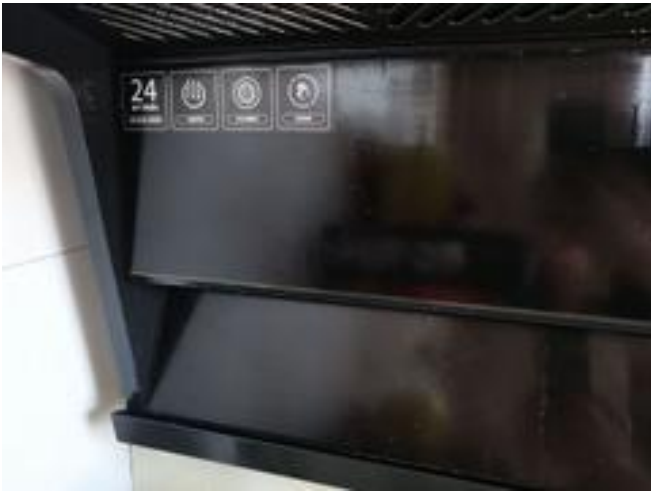
##### Range hood

| Item | Result | Notes |
|---|---|---|
| Range hood fan | Fail | Excessive grease accumulation on stove top hood |

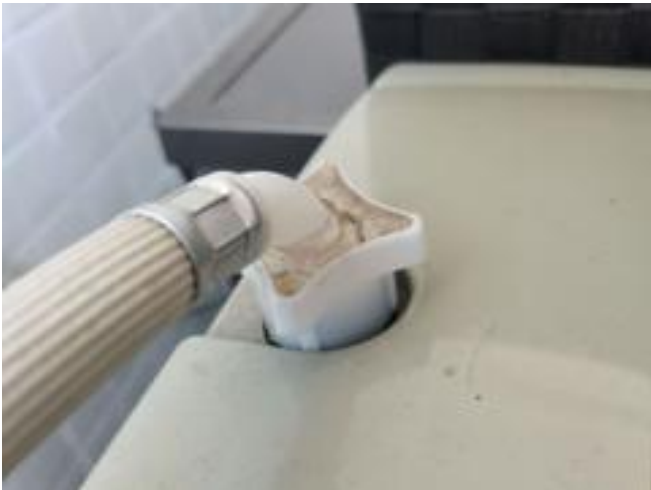
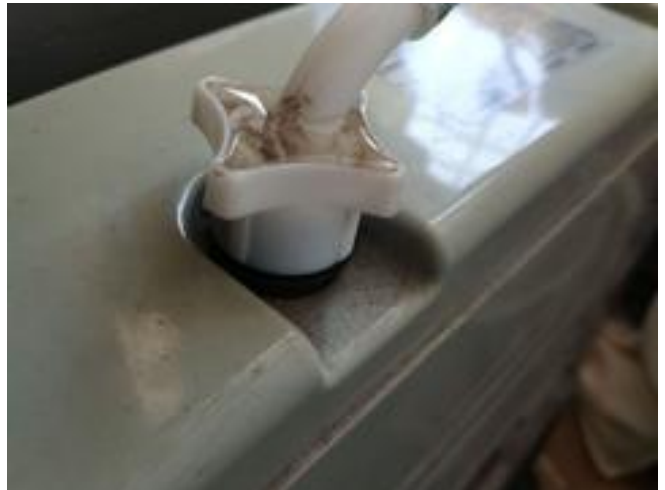
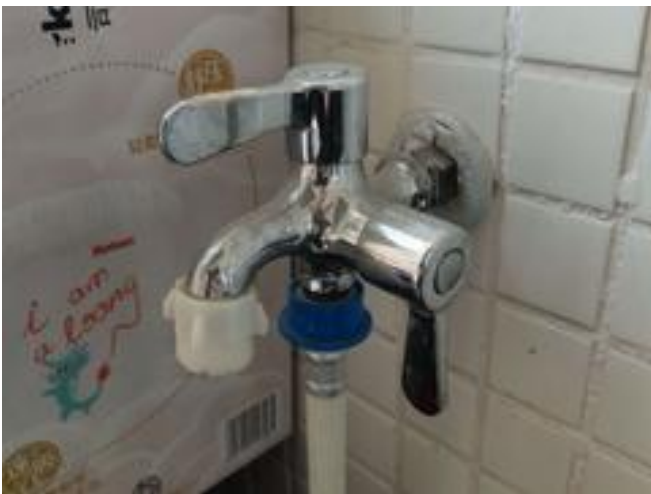
| Washer hookup | <b>Fail</b> | Water leaking is apparent |
